The historical reconstruction of the 1755 earthquake and tsunami in downtown Lisbon, Portugal

Abstract: The historical accounts of the 1755 earthquake and tsunami in Lisbon are quite vast providing a general overview of the disaster in the city. However, the details remain unknown. Therefore, the objective of this research is to understand and reconstruct the impact of the 1755 event (earthquake, tsunami, and fire) in downtown Lisbon. Thus, the historical data has been compiled and analyzed, to complement tsunami modeling and a field survey. Although census data are not very accurate, before the disaster there were about 5500 buildings and about 26,200 residents in downtown Lisbon; after the disaster, no records of the buildings were found and there were about 6000–8800 residents. There were about 1000 deaths in the study area. The results also show that the earthquake did not cause significant damage to most of the study area, which contradicts general knowledge. After the earthquake, a fire started that quickly spread throughout the city causing most damage to property. The tsunami hit mostly the west and central parts of the study area. The numerical model results show the tsun

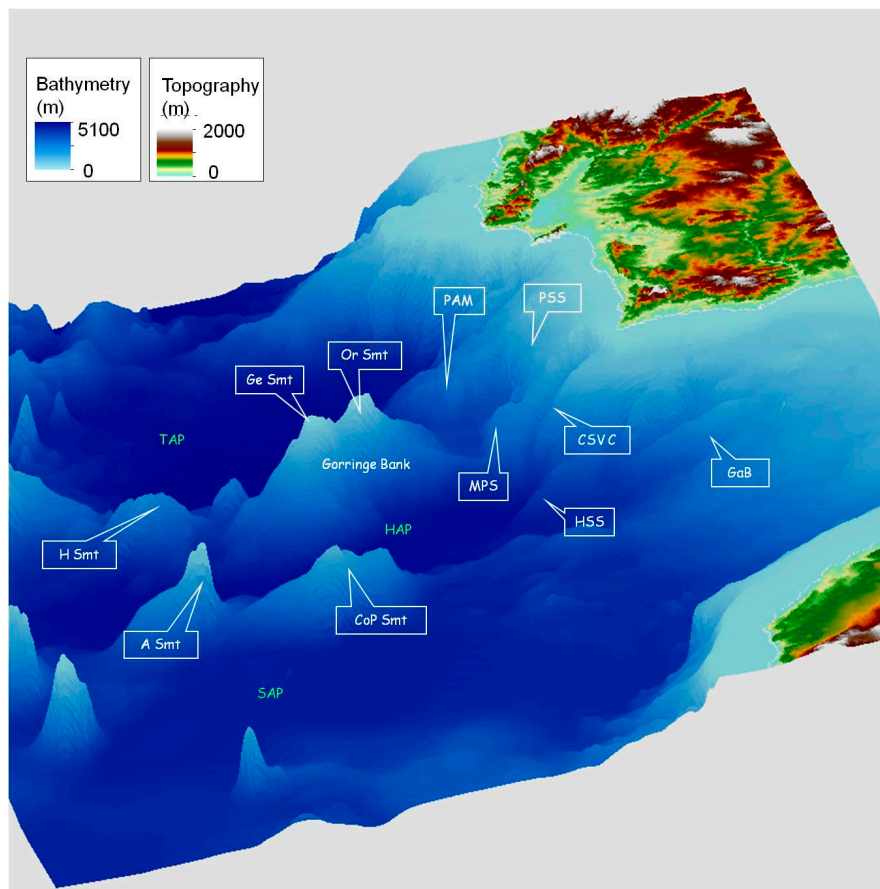
Figure 3. Portuguese continental margin represented in 3D. The most evident structure is the Goringe Bank with 200 km in length. Abbreviations by alphabetical order are: A Smt: Ampere Seamount; CoP Smt: Coral Patch Seamount; CSVC: Cabo São Vicente Canyon; GaB: Guadalquivir Bank; Ge Smt: Gettysburg Seamount; HAP: Horseshoe Abyssal Plain; H Smt: Hirondelle Seamount; HSS: horseshoe Scarp; MPS: Marquês de Pombal Scarp; Or Smt: Ormonde Seamount; PAM: Principes de Avis Mountain; PSS: Pereira de Sousa Scarp; SAP: Seine Abyssal Plain. TAP: Tagus Abyssal Plain (adapted from [4]).

The East Section is dominated by the Gorringer Bank (Figure 3). It is orientated in a SW–NE direction, consistent with the tectonics of the region, where the stress field is dominated by a trending approximately in the NW–SE direction [5]. It has dimensions of 200 km by 80 km and reaches 25 m below the mean sea level, separating Tagus and Horseshoe Abyssal Plains (Figure 3); it is asymmetrical, with the northern flank steeper than the southern. Gorringer Bank consists of 2 seamounts, the Gettysburg Seamount, in the Southwest and Ormonde Seamount, in the Northwest, separated by a saddle-shaped structure [13–15]. An idea of a thrust origin for the Gorringer Bank has been supported by in situ core sampling. A deep sea drilling project (DSDP) showed that the Gorringer Bank has a number of similarities to an ophiolite complex [15]. The Gettysburg Seamount appears to be essentially formed of serpentinite, whereas the basement of the Ormonde Seamount appears to consist of an oceanic section with gabbros of Berriasian age (143 Ma). It has been proposed by several authors that the Gorringer Bank is an uplifted thrust block of crustal and upper mantle rocks, resulting from the Euroasia–Africa collision (for ex., [14,15]). In fact, it has been shown that the Gorringer Bank overthrusts the Tagus Abyssal Plain for 4–5 km [16], although its seismic profile was inconclusive.

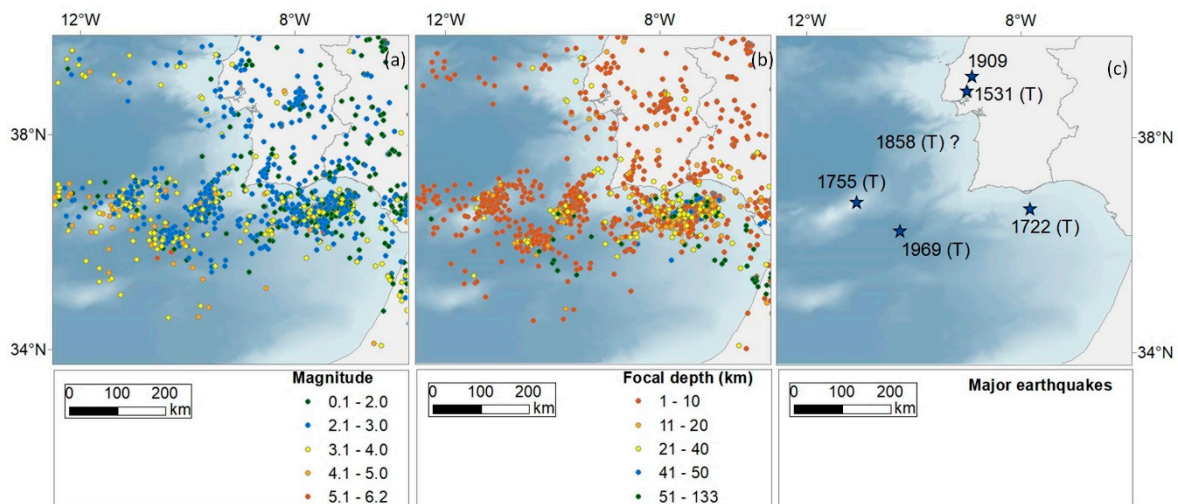
Figure 4. Seismicity of the East Section: (a) magnitude, (b) focal depth, (c) major earthquake. (T) indicates that the earthquake generated a tsunami. Data from United States Geological Survey (USGS), from 14 December 2000 to 14 December 2007 (adapted from [4,17]).

A small area between 7°W – 8°W and 36°N – 37°N shows significant seismic activity (Figure 4), but the bathymetry variation is not significant, compared with the previous structures. The authors did not find publications related to this area and further tectonic investigation should be carried out in this zone. Nevertheless, it is the most likely location of the source of the 1722 earthquake and tsunami (Figure 4c).

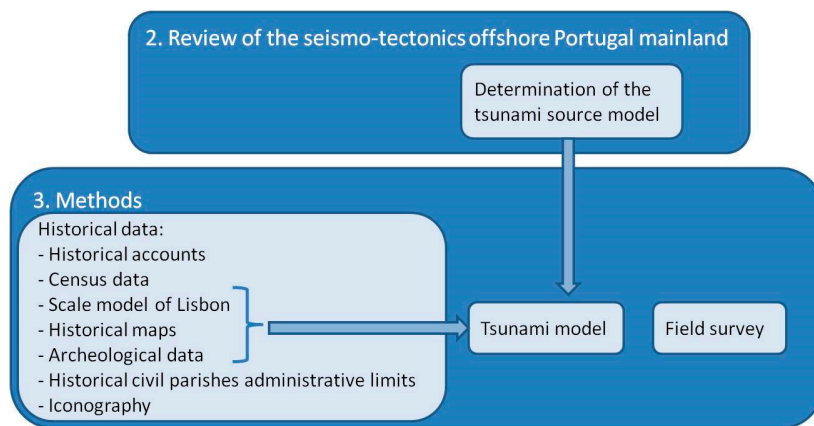
Figure 5. Schematic summary of the methods used in this study.

In this study several methods were used, as summarized in Figure 5. The historical data were compiled from different sources, namely historical accounts [29], and census data, both before and after the disaster [1,29]. In addition, the scale model of the city before the earthquake (Figure 6) allows a 3D perspective of Lisbon, including an indication of the buildings’ heights.

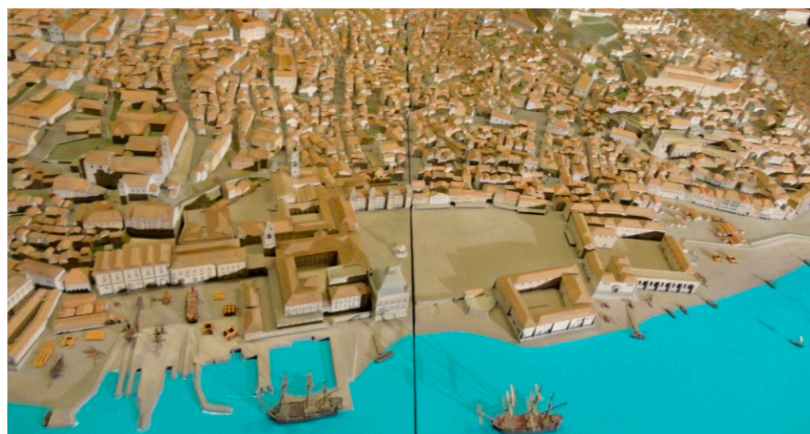
Figure 6. Part of the Lisbon city before the 1755 disaster. The scale model was built during the 1950s and is available at the Lisbon Museum to the public. Photo taken by the second author on 17 September 2018.

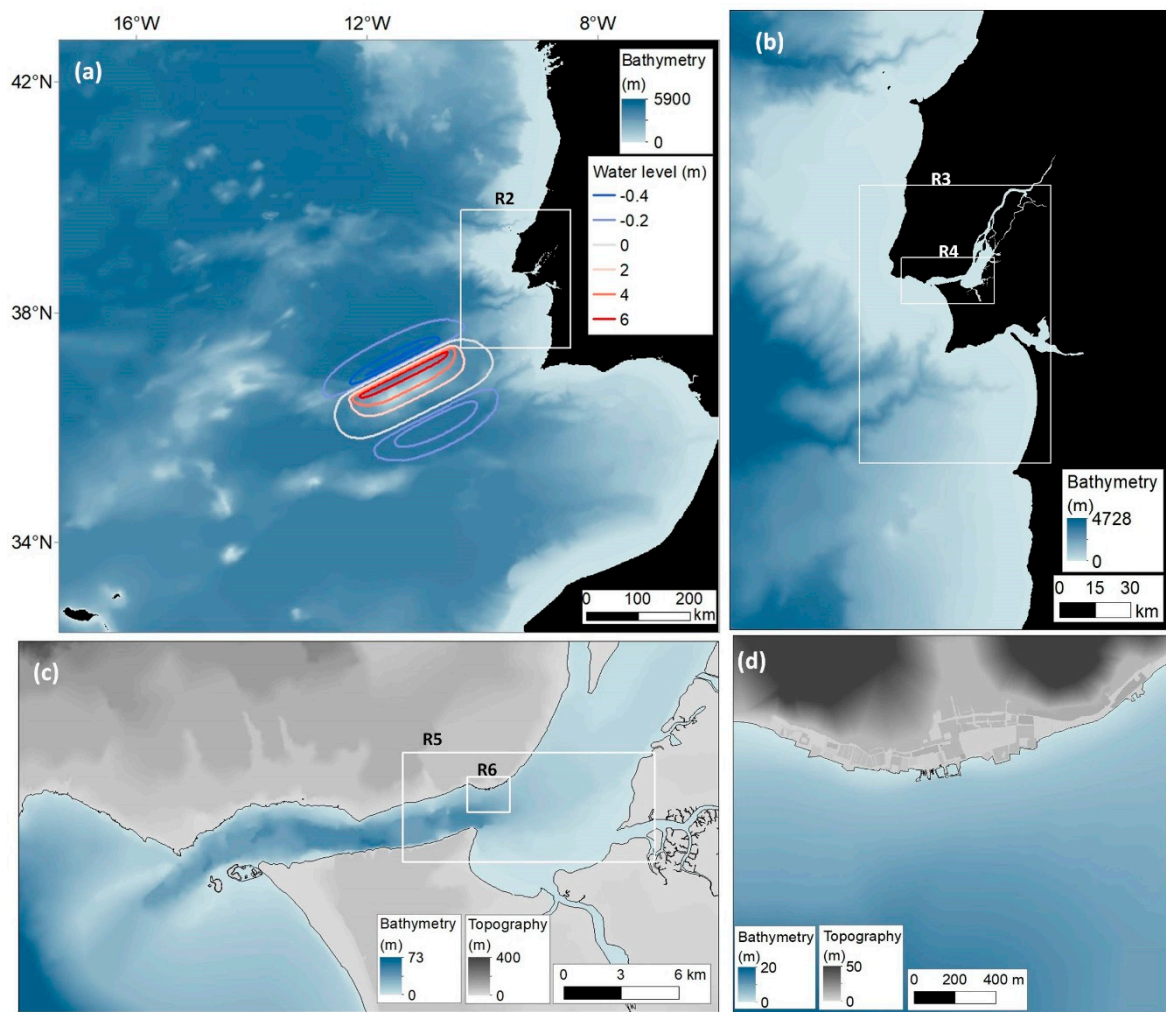
Figure 8. Conditions of the numerical model setting to downtown Lisbon: (a) region 1 and the initial sea surface displacement; (b) region 2 and the placement of regions 3 and 4; (c) details of region 4 and the placement of regions 5 and 6; (d) details of region 6.

The equations were applied to a nesting of six regions, where the regions have progressively smaller areas and finer grid cell sizes and are included in the previous region, as shown in Figure 8. The first region is the largest and has a cell size of 729 m. The results of the tsunami propagation for region 1 allow a comprehensive analysis as to how the tsunami waves spread out from the tsunami source area. Then, regions 2, 3 and 4 have cell sizes of 243, 81 and 27 m, respectively. Finally, regions 5 and 6 have cell sizes of 9 and 3 m, respectively, and include details of the coastal areas and topography. During construction of each region (Figure 8), several historical bathymetry charts and topographic maps were used, as indicated above. In computational region 6, tsunami inundation allows the tsunami run-up to be calculated. In addition, in region 6, a 3 m cell size is suitable for the study area because it accurately reproduces local natural topography variations as well as structures such as buildings and streets in downtown Lisbon before the earthquake.

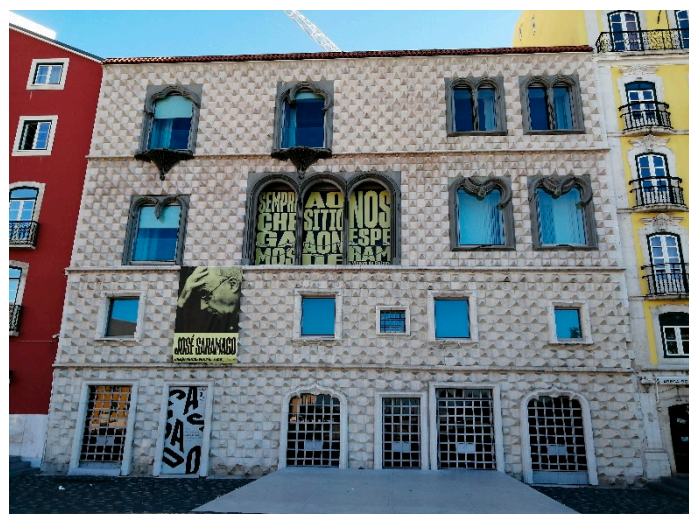
Figure 13. House of the Pointed Stones (#F), reconstructed after the 1755 disaster.

The field survey shows that the House of the Pointed Stones (F) still exists today (Figure 13). It was reconstructed on the same place (Figures 10–12). Although no information was found from the historical data, onsite information indicates the third and fourth floors of the building were destroyed during the 1755 disaster. This would be classified as a “partial collapse”, although no indication was provided if the damage was due to the earthquake, fire, or both.

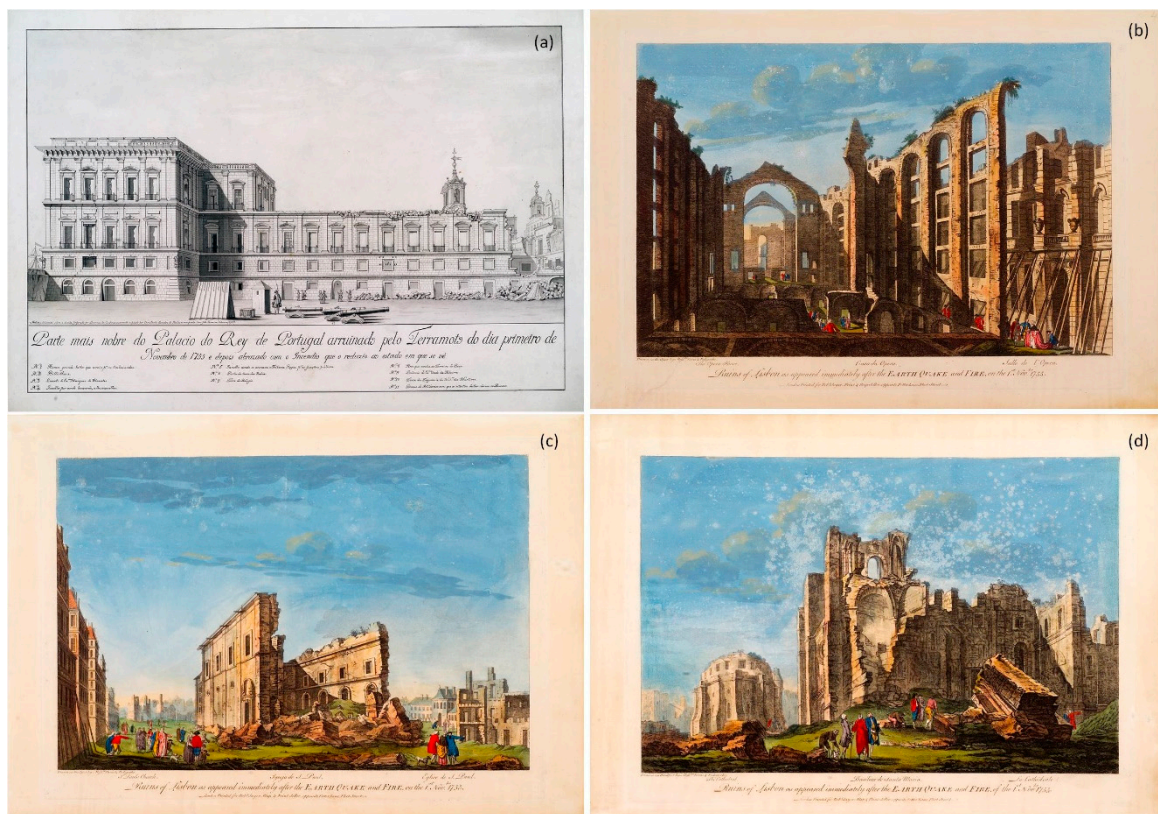
Figure 14. Iconography of the 1755 disaster at the study area: (a) copy of the drawing of the noblest part of the Royal Palace (#A) [41]; (b) painting of the Opera House (#N) [42]; (c) painting of the São Paulo church (#1) [43]; (d) painting of the Sé (#9) [44].

On the other hand, the iconography allows another perspective of the disaster on the study area. Figure 14 shows the Royal Palace (#A), with view from the Terreiro do Paço. As reported by the historical accounts, the earthquake caused minor damage to the building. In addition, the drawing shows that even after the fire the building itself did not collapse. Similarly, the Opera House (#N) did not suffer significant damages due to the earthquake. However, the fire caused the total collapse of the building, and only the major stone columns remained. The São Paulo church (#1) suffered partial collapse due to the earthquake. It was then impacted by the tsunami, although no information was found about its impact on the church. Later, the building was completely destroyed by the fire. The Sé (#9) was severely destroyed by both the earthquake and fire.
