# Study of the unexpected collapse of Ampurdán Tunnel (Spain) using Finite Element Model

**Abstract** The paper presents the case study of the Ampurdán tunnel that suffered an unexpected partial collapse during construction, due to the weathering of the claystone groundmass, after excavation and wetting by infiltration water. To overcome the problems encountered, the finite elements model was used to understand the behaviour of the tunnel and surrounding ground, to determine the geotechnical properties that lead to failure, allowing to choose suitable procedures for the construction of the tunnel. The parametric study performed simulated the deformations measured in situ and related with the tunnel collapse. The geotechnical parameters used for the weathered claystone, when compared with the ones of intact situation, correspond to a wide range of reductions between 8% in the apparent density and in the effective friction angle, up to 40% in the effective cohesion and 56% in the Young modulus.

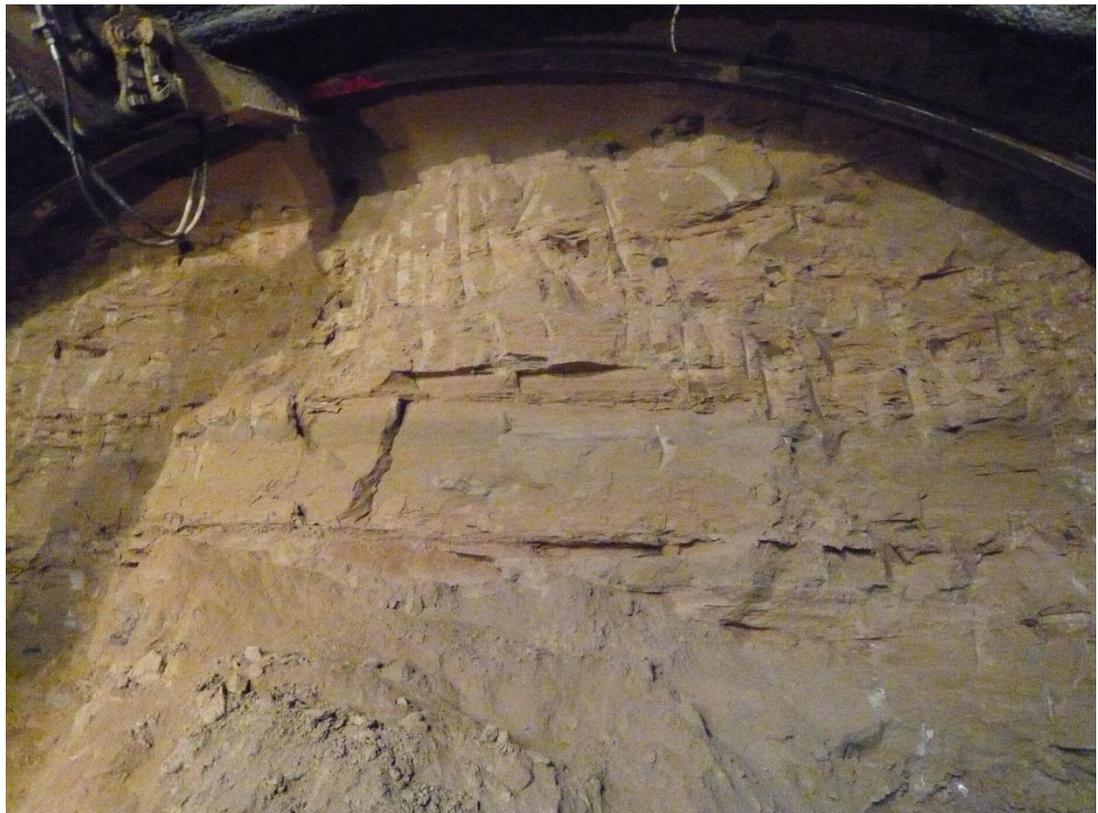
8  
9  
10 In subsequent excavation operations towards the south portal, the terrain  
11 homogeneity was confirmed, allowing obtaining a very well-defined excavation  
12 section, without overhangs, leaving a front with great stability (Fig. 4).  
13  
14  
15  
16  
17  
18  
19

Fig. 4. Excavation front in progress, presenting high homogeneity and good stability

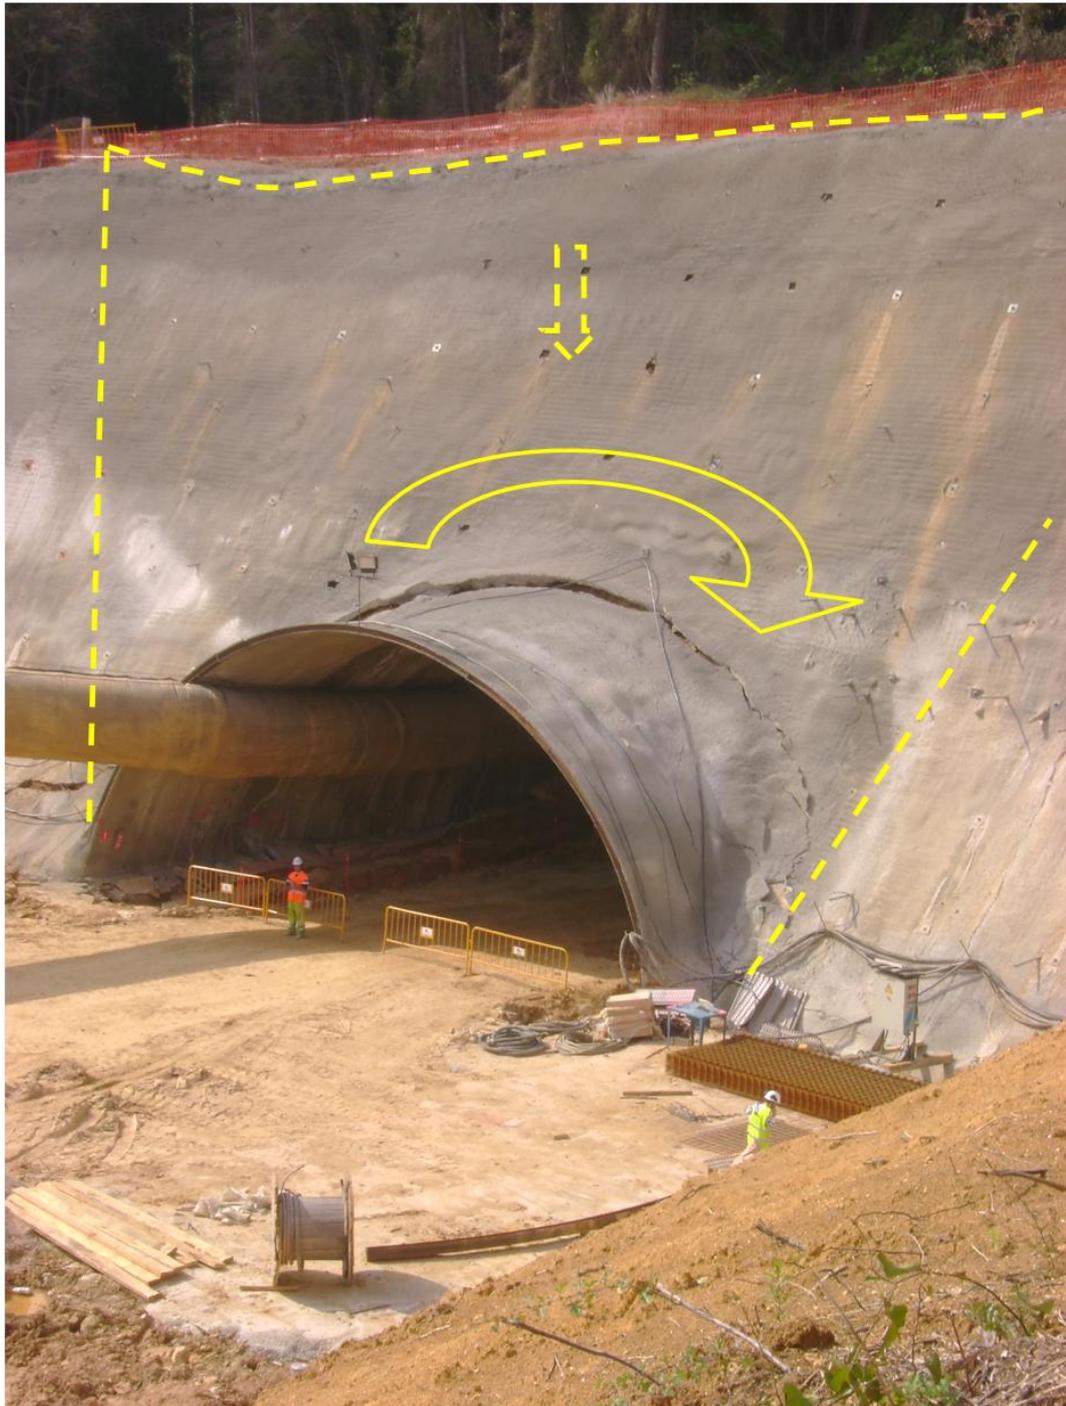
The most obvious external evidence of the failure (Fig. 6 and 7) was the existence of a depression about 0.5 m deep at the top of the portal, over the tunnel axis, and two longitudinal fissures above the sidewalls, 30 m long, 0.2-0.3 m wide, and about 2 m deep. The surfaces of these two fissures present a subvertical arrangement with slight inclination toward the tunnel axis, extending from the surface towards the sidewalls, roughly at the level of the top heading (Fig. 6).

6 The shotcrete fissure in the portal face, above the micropiles umbrella, can be  
7 interpreted as the result of the portal zone rotation, sinking more on the left side  
8 than in the right side (Fig. 6 and 7). In the tunnel interior, it was possible to  
9 appreciate the left mortar gutter totally raised by the downward movement of the  
10 sidewalls (Fig. 8).  
11  
12  
13  
14  
15

Fig. 6 Overview of the North portal after the collapse. The horizontal dashed line highlights the 0.5 m depression at the top of the portal. The dashed harrow points the downward movement. The vertical and inclined dashed lines indicate the two longitudinal fissures 30 m long, The circular arrow indicates the circular shape of the fissure above de tunnel lining

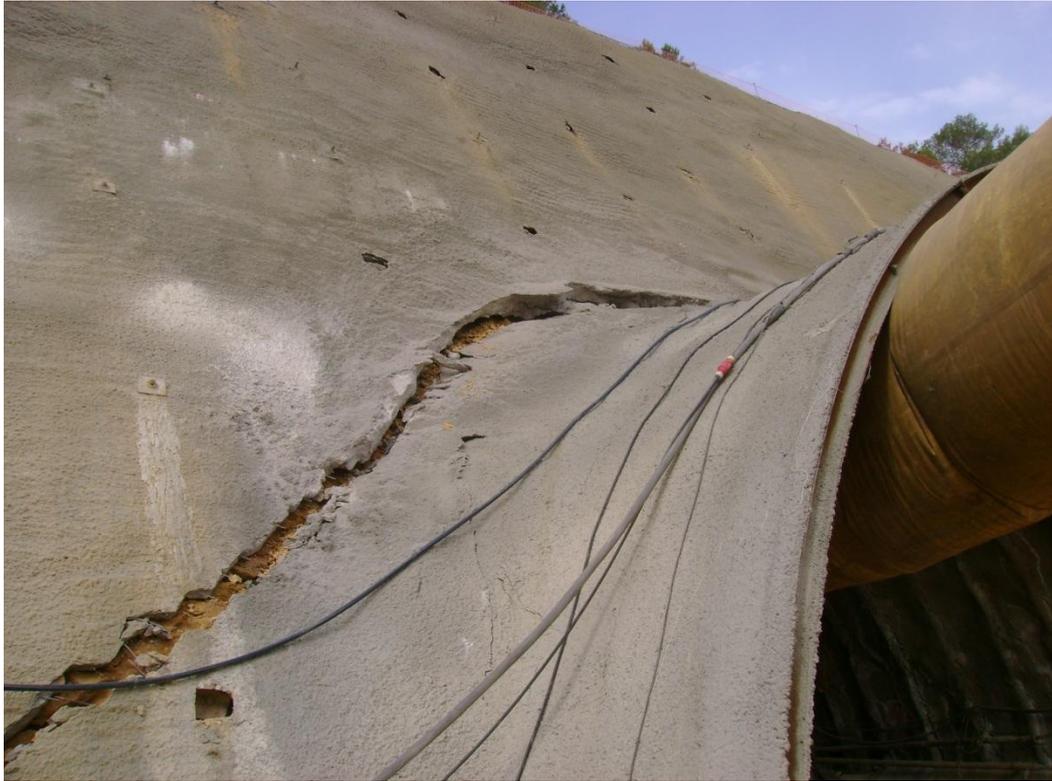
Another evident trace of the failure was the open fissure in the shotcrete at the portal face, immediately above the lining (Fig. 7) with the separation of the shotcrete from de ground. It could clearly be seen that part of the rockbolts were still tight to the collapsed ground and that the shotcrete partially maintained its position.

Fig. 7. Fissure developed above the North portal lining.

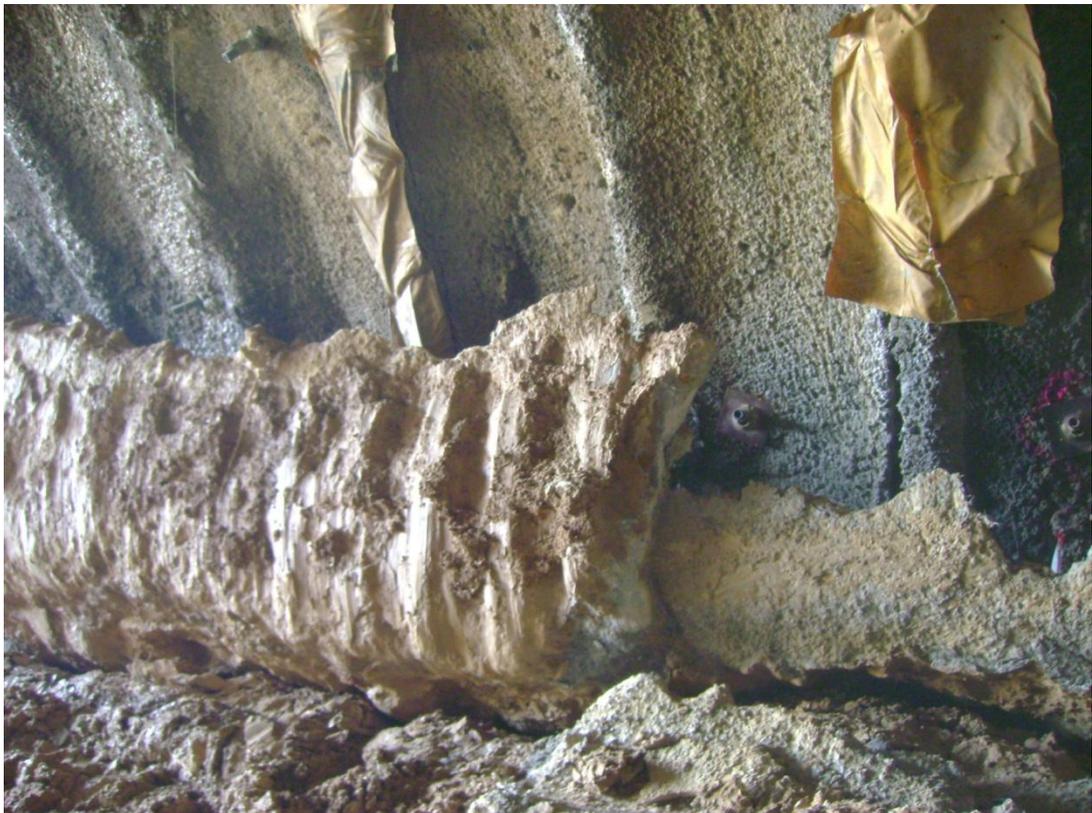
Fig. 8 View of the provisional mortar gutter rotated upwards on the left side of the tunnel
