Defects of non-loadbearing masonry walls due to partial basal supports

Abstract

Keywords: Masonry walls; Cracking; Strength; Stress; Strain

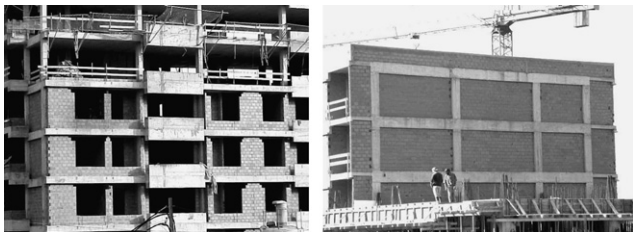
Fig. 1. Typical concrete structure of Portuguese buildings filled with non-loadbearing masonry walls.

A very high percentage of Portuguese buildings constructed during the last 40 years have an orthogonal concrete structure of columns and beams, with internal rigid connections. The structure frames are filled with masonry walls using typical hollow clay bricks (see Fig. 1). Generally, the design of these buildings doesn't require any relevant resistance for the walls, and neglects also their natural contribution to increase building stiffness, that influences the structural response to seismic actions.

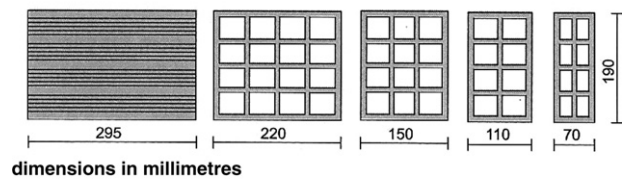
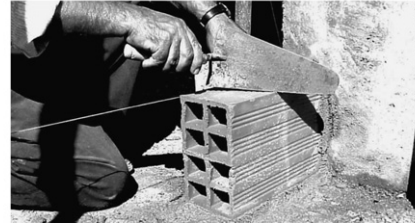
Fig. 2. Portuguese standard models for hollow clay bricks.

Portuguese standards define four hollow clay brick models that are represented in Fig. 2. In spite of the excellent raw materials available and used by national industry, these clay bricks are often very weak, in consequence of their internal geometry. The building envelope is obtained with single or double leaf masonry walls of hollow clay bricks. Double wall leafs are 110 or 150 mm thick and the ventilated air gap between them is 50–100 mm wide [2]. It is common to partially fill this air gap with synthetic insulating boards 30–40 mm thick, reducing heating energy consumption and increasing building comfort levels. The use of wall ties connecting the two leafs of cavity walls is still a very rare practice.

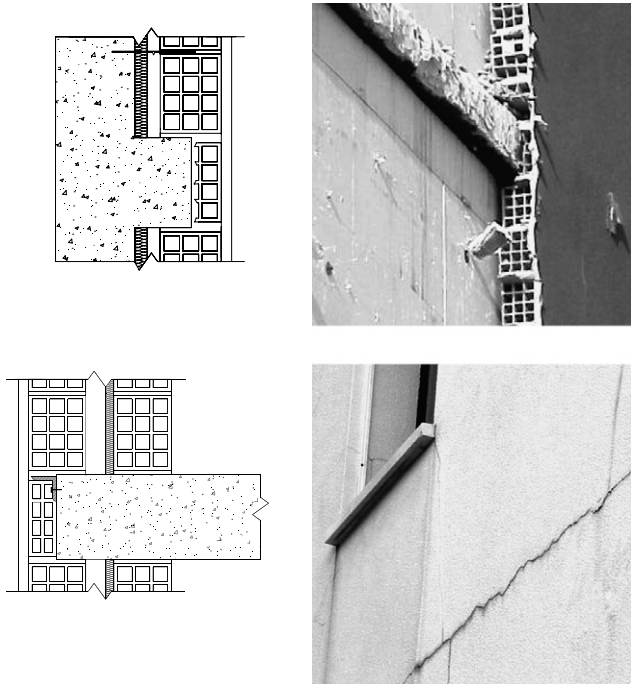
Fig. 3. Two examples of severe mechanical defects resulting from inadequate correction of thermal bridges, using masonry walls partially supported (adapted from [7]).

Unfortunately, this method is frequently adopted without any care for wall tying and without an accurate evaluation of brick resistance and masonry deformation. Fig. 3 shows two case studies where severe cracking occurred, imposing, in the first situation, the demolition and re-construction of the external leaf of the wall.

The major cause for the cracking and instability problems observed in several buildings is the reduced width of the support of the walls on the floor slabs or beams. This situation leads to high local stresses which effects are increased by brick internal geometry [8], as revealed in further on.

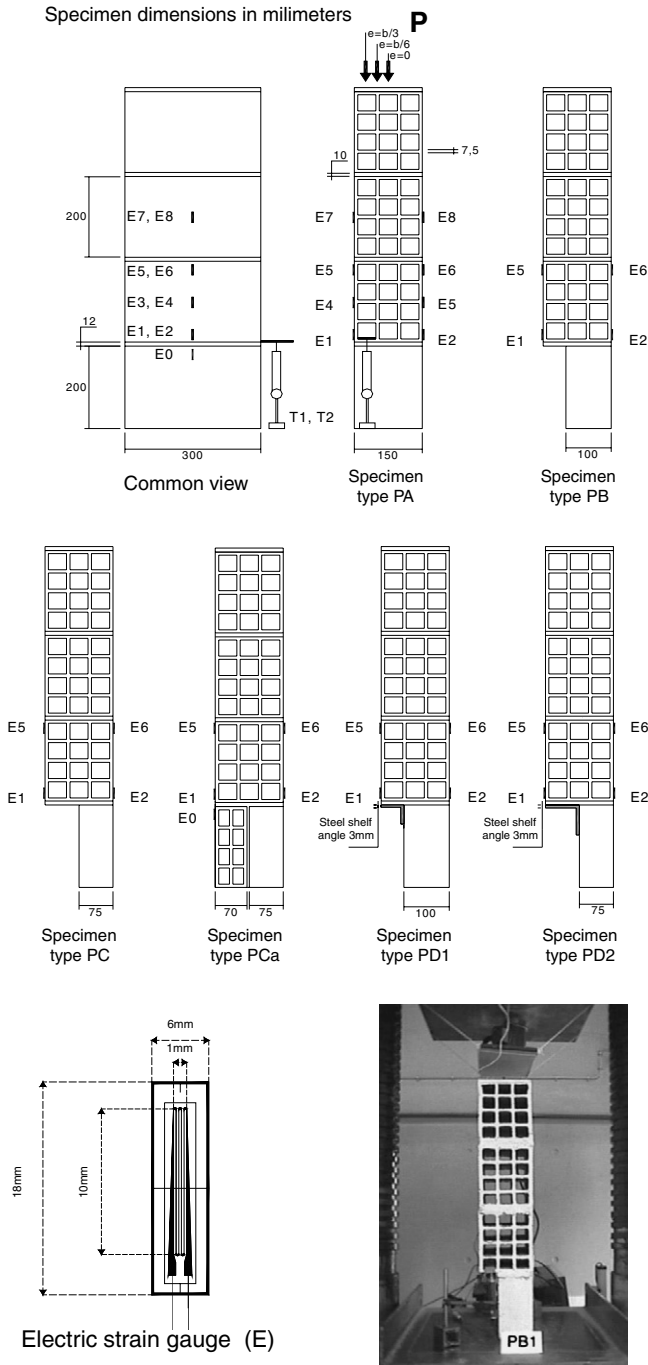
Fig. 4. Geometry and instrumentation of wall specimens.

In Fig. 4, instrumentation and preparation of testing is illustrated clearly, indicating the position of the electrical strain gauges bonded to the specimens.

Specimen type PA1 was fully instrumented with strain gauges 1–8; specimens PA2 and PA3 were instrumented only with strain gauges 3 and 4; on specimens type PB1, PC1, PD1 and PD2 we applied only strain gauges 1, 2, 5 and 6; on specimen type PCa we applied strain gauges 0, 1, 2, 5 and 6 (see Fig. 4).

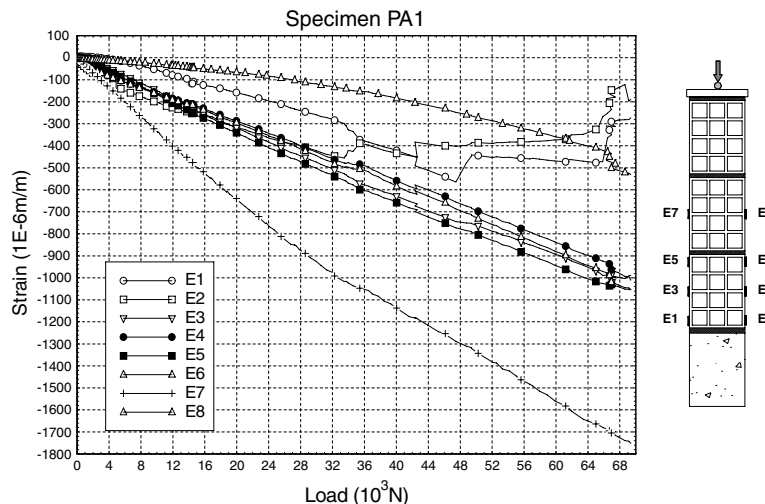
Fig. 6. Vertical strains for specimen PA1.

Observing failure evolution of this specimen we realise that the fragility and geometry of these units (clay bricks) rule the establishment and comprehension of cracking patterns. The main results of this test are shown in Table 1 and Fig. 6.

According to Fig. 6, all strains are negative and normally increase when nearer to the concrete base support. But in this case the disturbance of strain gauge readings during testing is very noticeable (E1, E7, E6) when cracking occurs aggravated by its level of intensity and damage.

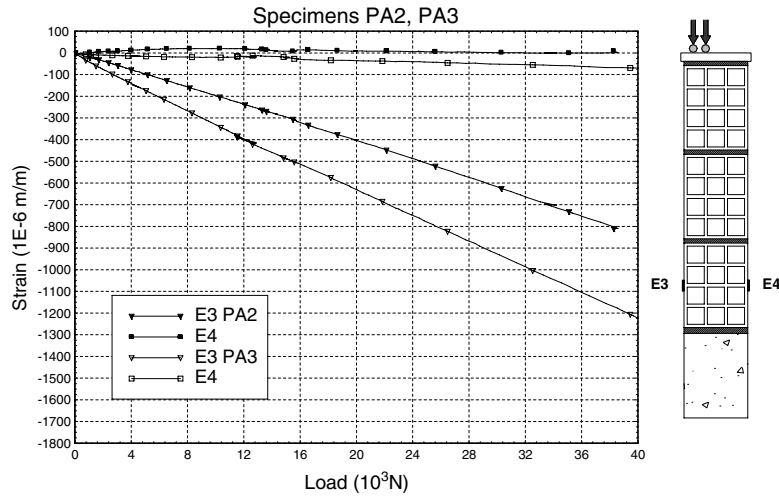
Fig. 7. Vertical strains for specimens PA2 and PA3.

According to Figs. 7 and 8, the strain level for strain gauge 2 of specimen PA2 is higher than on specimen PA3, which has greater eccentricity of load, this result can be explained by the way the load is applied on both

specimens due to their correspondent eccentricity values (see Fig. 4), the loading conditions for specimen PA2 create a privileged stress-path through the a inner septum alignment. Furthermore if we compare the difference between the strain gauge values on both sides of both specimens, we notice higher differentiability of strain values for specimen PA3.

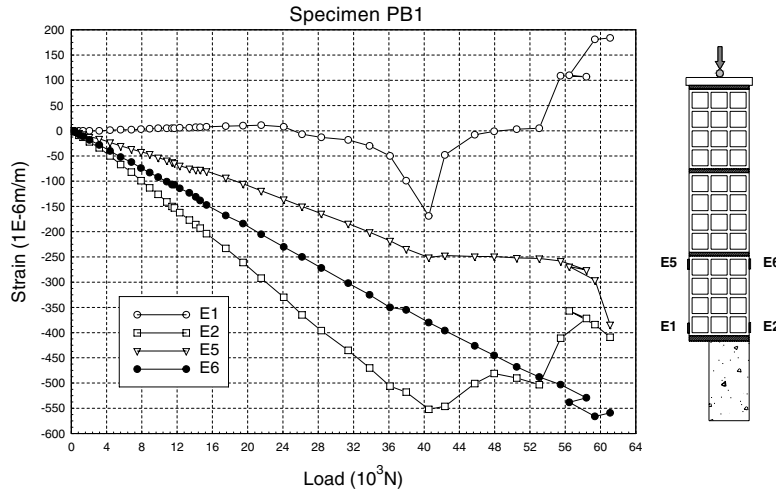
Fig. 9. Vertical strains for specimen PB1.

Fracture and cleaving of the lower brick are noticeable and they are clearly responsible for the final failure. Positive strains values registered by strain gauge 1, even though very small, (50 μ) reveal a positive tension state over that unsupported area (see Figs. 9 and 10).

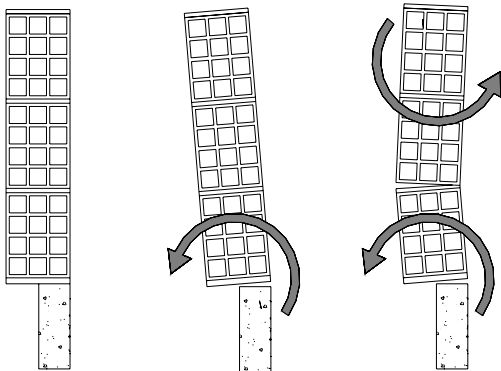
Fig. 11. Rotation phenomena of specimen PC1.

Through specimen PC1 tests, we observed very compromising rotation phenomena, which influences very clearly failure configuration and cracking evolution. Cracking appears very seriously and critical at the region of transition of support conditions because of internal shear forces instated and, also, at mortar bed joints as a consequence of rotation (see Fig. 11).

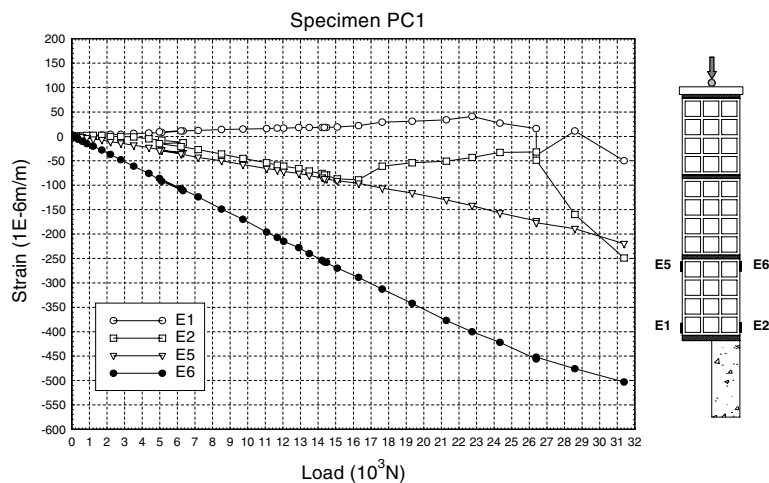
Fig. 12. Vertical strains for specimen PC1.

Strain analysis (see Fig. 12) shows a lower level of strain values at strain gauges 2 and 5 in comparison with specimens PB1 and PA1, as a consequence of an allowable flexibility and internal adjustment of the wall specimen. These support conditions are responsible for a very significant reduction of strength capacity (see Table 4). Once this specimen cracks, the aggravation of opened cracks leads to quick failure.

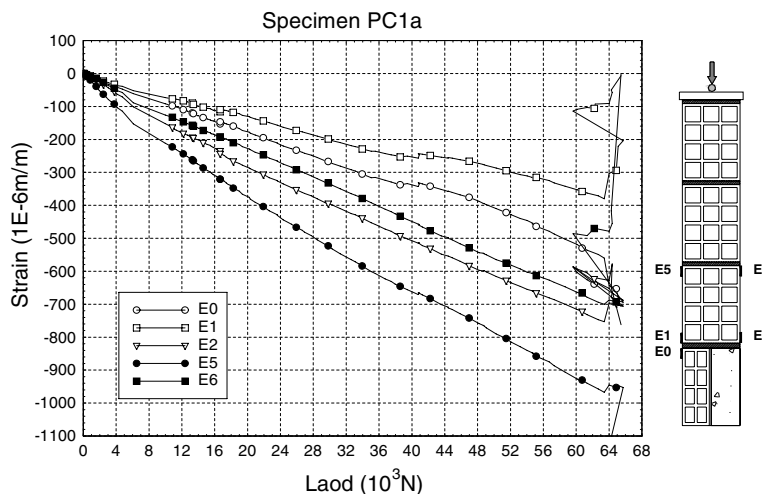
Fig. 14. Vertical strains for specimen PC1a.

The test results for specimen PC1a are presented in Figs. 13 and 14 and also in Table 5.

The type of failure and the appearing of cracking are similar to specimen PA1. First cracking occurs for values of load under 50% of failure load, suggesting that the opening of cracks is not so severe as revealed with specimen type PC1. Experimental tests showed that the difference between strain values on the supported side over the ceramic

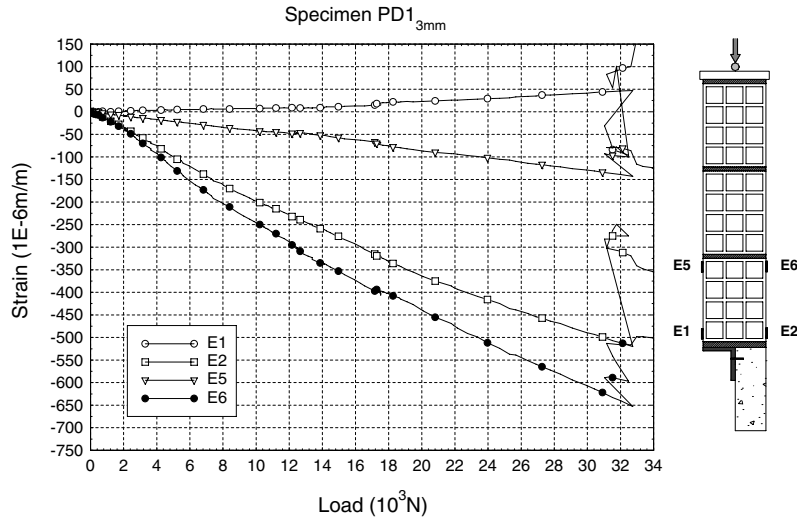
Fig. 17. Vertical strains for specimen PD1_{3mm}.

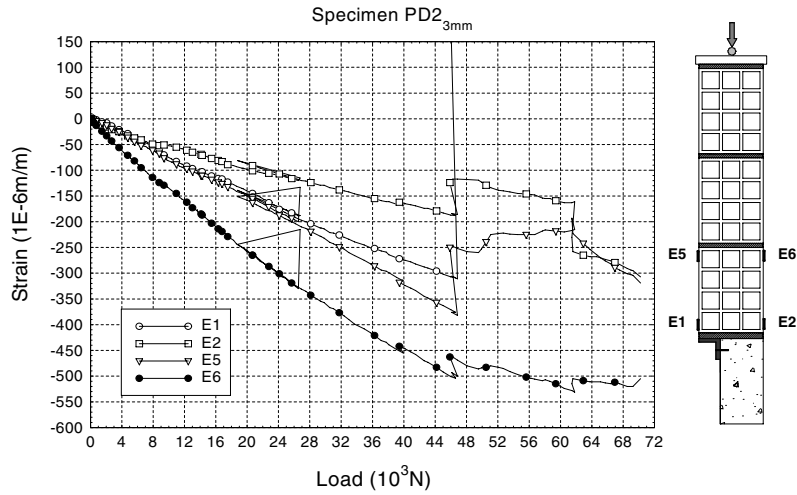
Fig. 18. Vertical strains for specimen PD2_{3mm}.

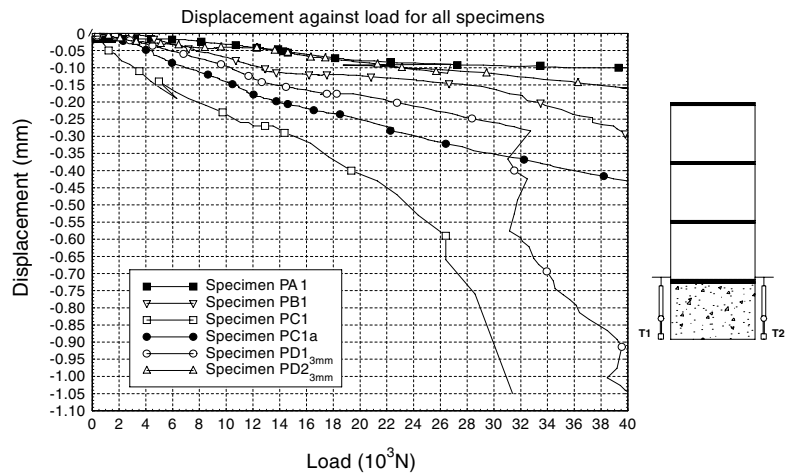
Fig. 19. Comparison of measured displacements of all specimens.

Comparing recorded displacements among the six specimens studied it is clear that the displacement and rotation phenomena of the wall is increased and aggravated in consequence of the lack of sufficient support of the breadth of the wall.

However these results must be assumed with some precaution, due to early cracking (under small loads) near the monitored displacement point.

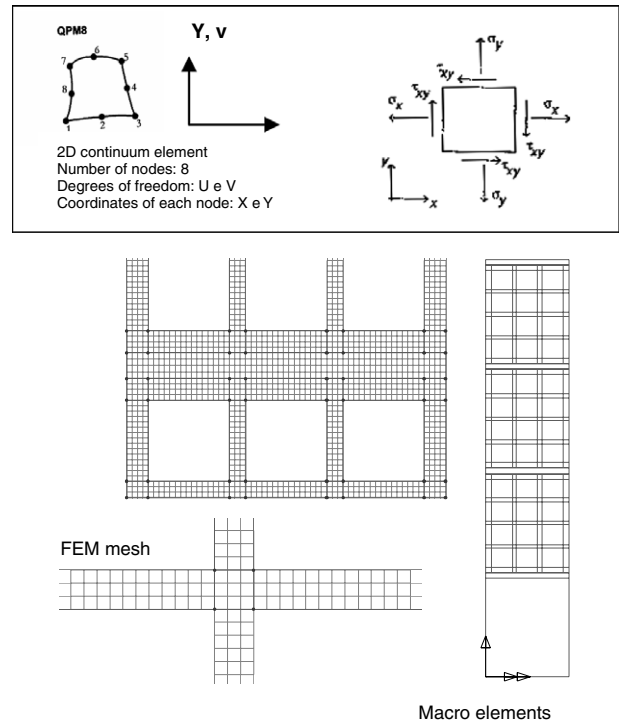
Fig. 20. Description of FEM element and mesh.

To assess and interpret the behaviour and cracking of the wall specimens it was carried out a linear elastic analysis, considering a plane stress state using 2D continuum isoparametric elements of eight nodes (see Fig. 20).
