LONG-TERM EFFECTS ON STRUCTURAL GLASS

Dissertação de Mestrado Integrado em Engenharia Civil, na área de Especialização em Mecânica Estrutural,
orientada pela Professora Doutora Sandra Filomena da Silva Jordão Alves e pela Professora Doutora Chiara Bedon.

Coimbra, 8 de Setembro de 2017

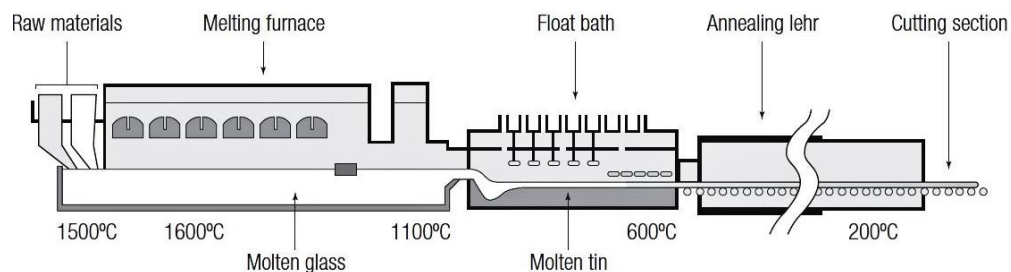
Figure 2.4 - Schematic representation of the float process, (O'Regan, 2014).

This process is initiated by melting the raw materials in a furnace at a temperature close to 1500°C to form molten glass (O'Regan, 2014). Soon after that, the molten glass is poured into a bath of molten tin at around 1100°C (Figure 2.4). Since the density of the glass is much lower than the density of the tin, the glass is able to float above it, forming glass sheets with uniform thickness and smooth surfaces. While the surface facing the tin is designated “tin side”, the other surface is referred to as “air side” (Louter, 2011). As the glass flows in the tin bath, its temperature is lowered until about 600°C. Thereafter the glass is removed from the bath and placed in an oven called the annealing lehr at 200°C, where it is cooled down at a very slow rate, preventing the glass from building up residual internal stresses. Subsequently, the glass sheets are inspected for visible defects and cut.

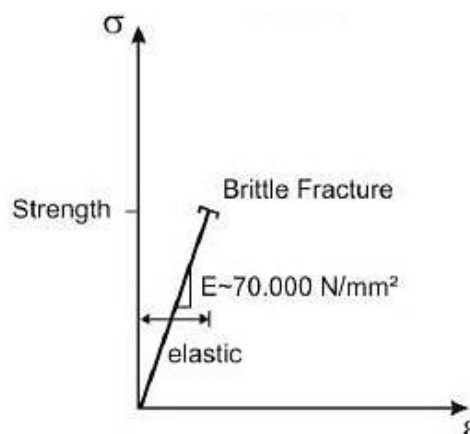
Figure 2.6 - Stress-strain diagram of float glass, (JRC, 2014).

From a mechanical perspective, glass presents an almost perfect linear-elastic and isotropic behavior. As shown in Figure 2.6, its stress-strain relation is perfectly linear until the sudden fracture of the glass steel. The breakage of glass develops in this manner because this material is incapable of yielding in order to redistribute high stresses like other structural materials such as steel.

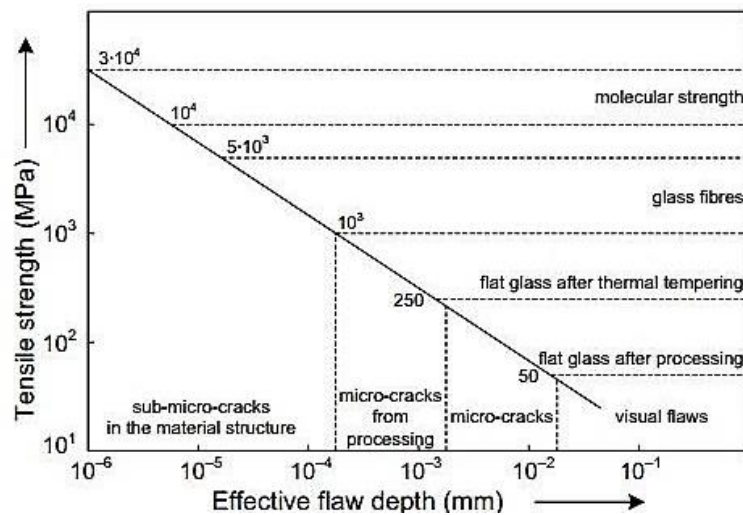
Figure 2.7 - Typical tensile strength as function of the flaw depth, (Haldimann, *et al.*, 2008).

which is why the practical strength of glass is much lower than the theoretical. Consequently, it becomes logical to conclude that the strength of a glass element depends on the depth of its largest flaw (critical flaw). The larger the critical flaw depth, the lower the tensile strength of the glass can be expected to be (Figure 2.7).

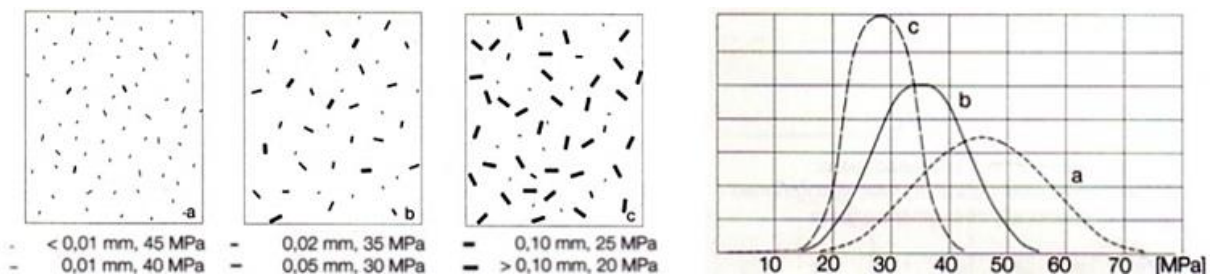
Figure 2.8 – Statistical distribution of the tensile strength of glass with the increase of superficial damage, with a) surface of a new glass, b) surface of glass after climatic actions, and c) surface of glass with time-related damages (adapted from Valarinho, 2010).

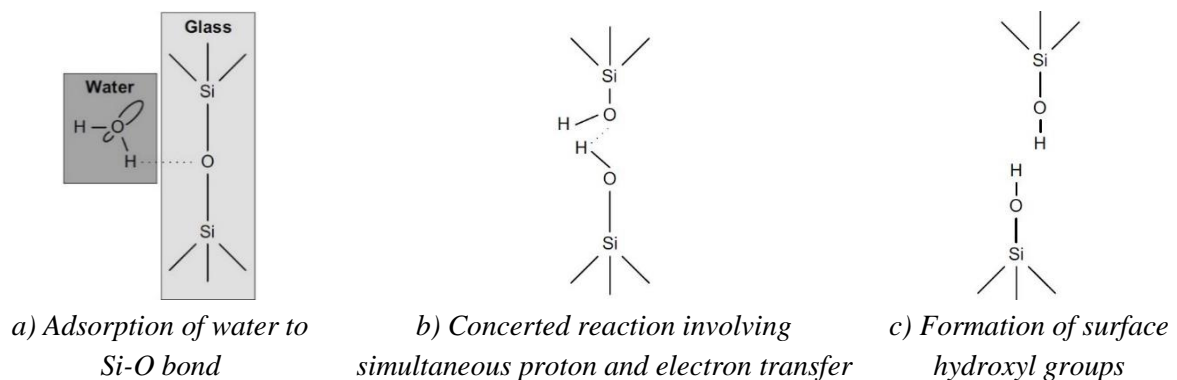
Figure 2.9 – Schematic representation of the chemical reaction of stress corrosion at the crack tip, (Haldimann, *et al.*, 2008).

Stress Corrosion is associated with a chemical process described by the “*Classical Stress Corrosion Theory*”. The chemical reaction that develops between water and the silica molecules of the glass element results in the sharpening and lengthening of the crack tip, causing the development of even higher stress levels (Equation (2) and Figure 2.9) (Louter, 2011).

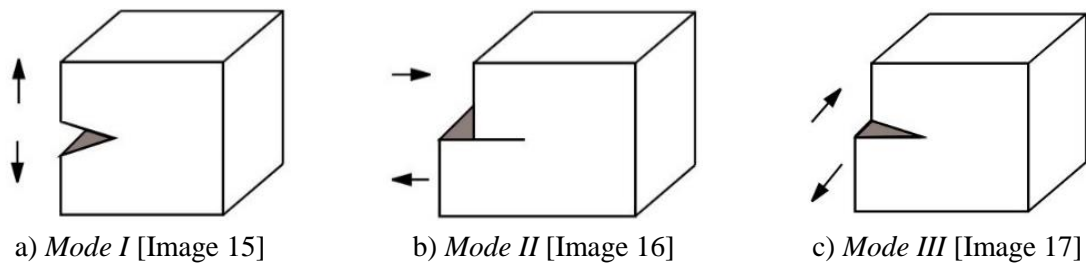
Figure 2.10 – Fracture modes according to the LEFM.

In the Linear Elastic Fracture Mechanics (LEFM), there have been distinguished three fracture modes: Mode I (opening mode): corresponds to normal separation of the crack walls develops under the influence of tensile stresses (Figure 2.10 a)); Mode II (sliding mode): corresponds to longitudinal shearing of the crack walls in a direction normal to the crack front (Figure 2.10 b)); Mode III (tearing mode): corresponds to lateral shearing parallel to the crack front (Figure 2.10 c)) (Louter, 2011, apud Lawn,1993).

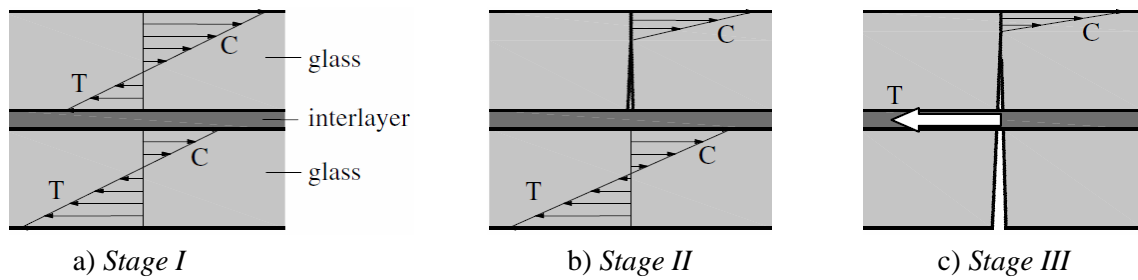
Figure 2.13 – Stages of laminated glass during failure, (Belis, et al., 2008).

In what concerns the level of damages if laminated elements composed of two glass sheets and one interlayer, as is the case of the models adopted in the present dissertation, Kott defined three stages (Belis, *et al.*, 2008 apud Kott, 2006). Stage I represent the situation in which all the glass sheets are still intact which means that the bending stress distribution in the glass depends mostly on the shear modulus of the adhesive layer (Figure 2.13 a)). In Stage II, the rupture of one of the glass sheets has already occurred and the existing bending stresses are mainly supported by the remaining unbroken glass layer (Figure 2.13 b)). The final stage (Stage III) corresponds to the situation in which both glass layers are broken and all the tensile stresses are supported by the lamination film which causes it to suffer considerable deformations and ultimately can result in the complete collapse of the structure (Figure 2.13 c)).

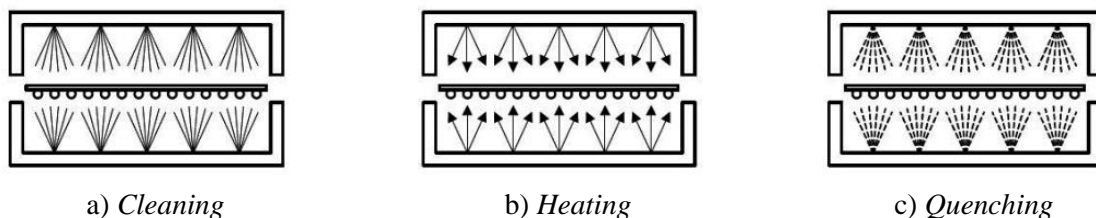
Figure 2.14 - Representation of the tempering process, (Haldimann, *et al.*, 2008).

In the heat treatment processes, the glass layers are heated until roughly 620 to 675 °C (the glass transformation temperature (T_G)) and subsequently cooled by air jets (Figure 2.14).

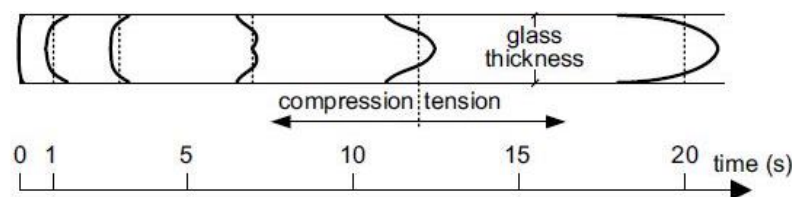
Figure 2.15 - Stress field during the tempering process, (Haldimann, *et al.*, 2008).

The thermal treatment causes the external surface to cool much faster than the internal area of the glass layers. As a result, compressive residual stresses are originated in the glass surfaces and tensile residual stresses are originated in the interior of the glass (Figure 2.15).

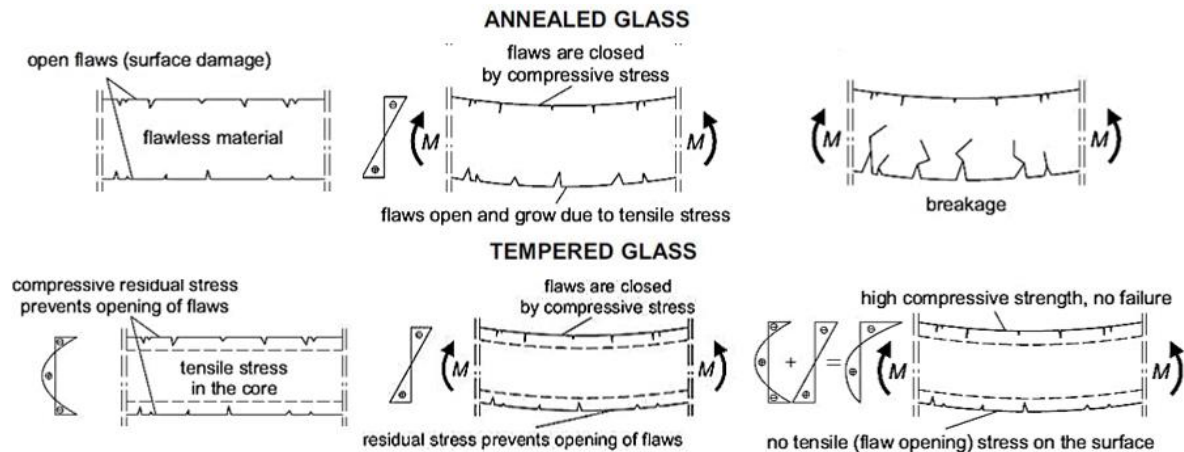
Figure 2.16 - The principle of glass tempering, (adapted from Haldimann, *et al.*, 2008).

It is important to note that this reinforcement technique is only effective because of the low coefficient of thermal expansion that characterizes glass, which enables a slow progression of the heat and allows the internal stresses to develop. As long as the external tensile stresses are lower than the acting compressive residual stresses, this procedure protects the surface flaws from growing, as represented in Figure 2.16.

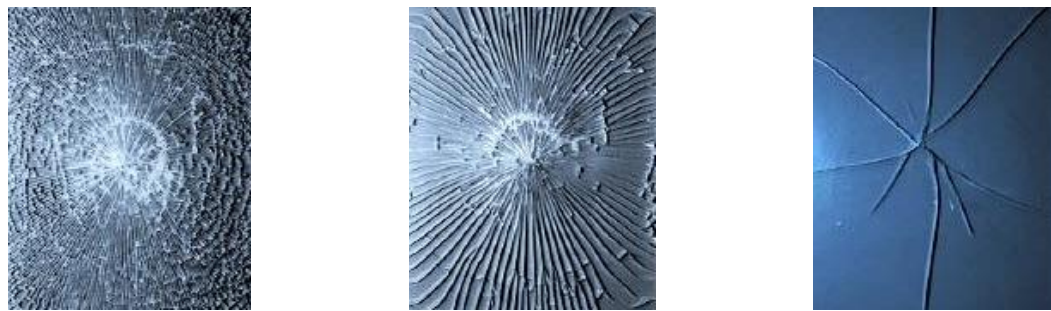
a) Fully-tempered glass b) Heat-strengthened glass c) Annealed glass

In the case of annealed float glass, the value of internal stresses is insignificant. For this reason, it breaks in considerably larger fragments than heat-treated glass, which causes it to have the lowest fragmentation of the three analyzed glass types (Figure 2.17 c)).

As demonstrated in Figure 2.17, the smaller the fragments that result from the rupture of the glass sheet, the worse the post-breakage behavior of the laminated glass will be, as the “arch” effect enabled by the lamination film becomes less efficient with the diminishment of the fragments (Haldimann, *et al.*, 2008).

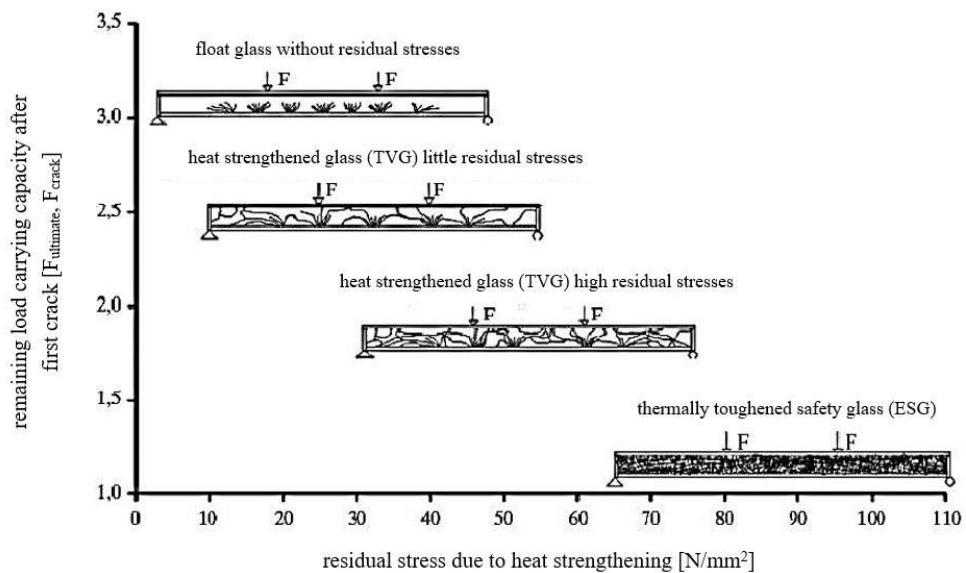
Figure 2.18 - Relation of residual pre-stress and remaining load-carrying capacity for different glass types, (Louter, 2011).

As represented in Figure 2.18, the values of the compressive surface stresses introduced by the tempering process can vary between 80MPa and 170MPa for fully-tempered soda-lime silica glass. In the case of heat-strengthened glass, this value fluctuates between 24MPa and 52MPa.

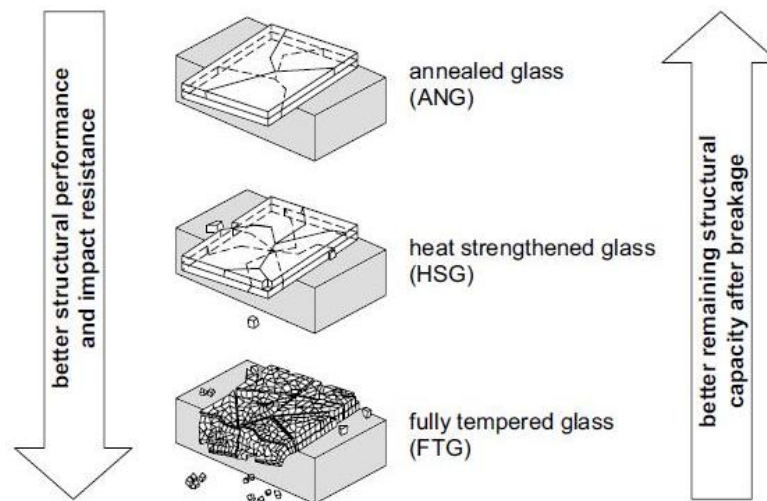
Figure 2.19 - Post-breakage behavior of laminated glass for different glass types, (Haldimann, *et al.*, 2008).

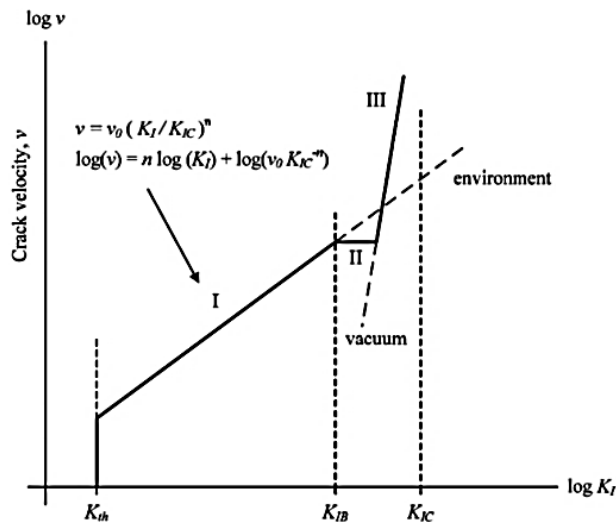
Figure 3.1 - Schematic representation of the relation between the (v) and (K_I), (Louter, 2011).

The relation between K_I and the crack velocity (v) is represented in Figure 3.1 This relation depends on various aspects such as humidity, temperature, corrosive media and pH values, chemical composition of the glass and the loading rate (Haldimann, et al., 2008).

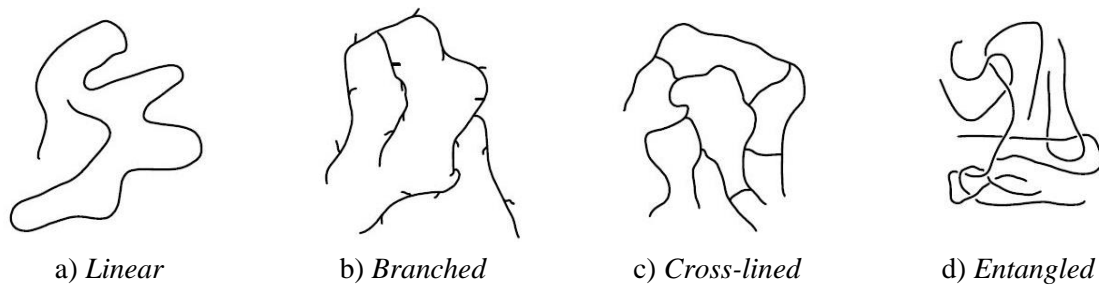
Figure 3.2 – Schematic representation of the structure of polymer materials, (Louter, 2011).

physical bonding forces. While physical bonds can be reversed when subjected to heat, solvents or mechanical forces, chemical bonds are practically irreversible. Furthermore, different types of bonds result in the existence of different structures: linear (Figure 3.2 a)), branched (Figure 3.2 b)), cross-lined (Figure 3.2 c)) and entangled (Figure 3.2 d)).

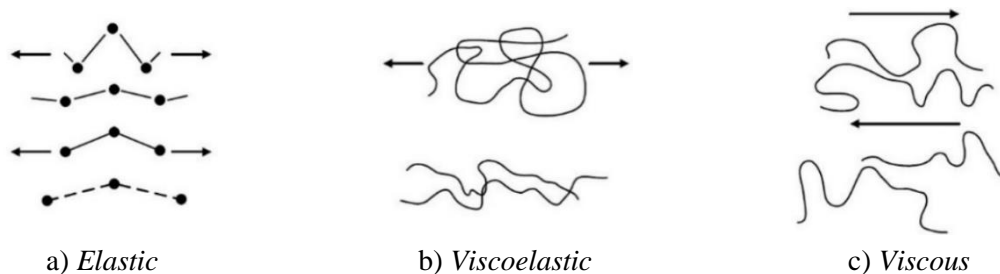
Figure 3.3 – Schematic representation of the deformation in polymers, (Louter, 2011).

Upon loading, polymers are known to present three different deformation types: instantaneous elastic deformation, which is caused by the instantaneous modification of the atomic distance and by the distortion of the valence angles between fixed chemical bonds (Figure 3.3 a)); time-dependent viscoelastic deformation due to the stretching of the molecular chains (Figure 3.3 b)); time-dependent viscous deformation resultant from the movement of the molecular chains (Figure 3.3 c)). It is important to mention that, from among these types of deformation, only the viscous deformation is completely irreversible.

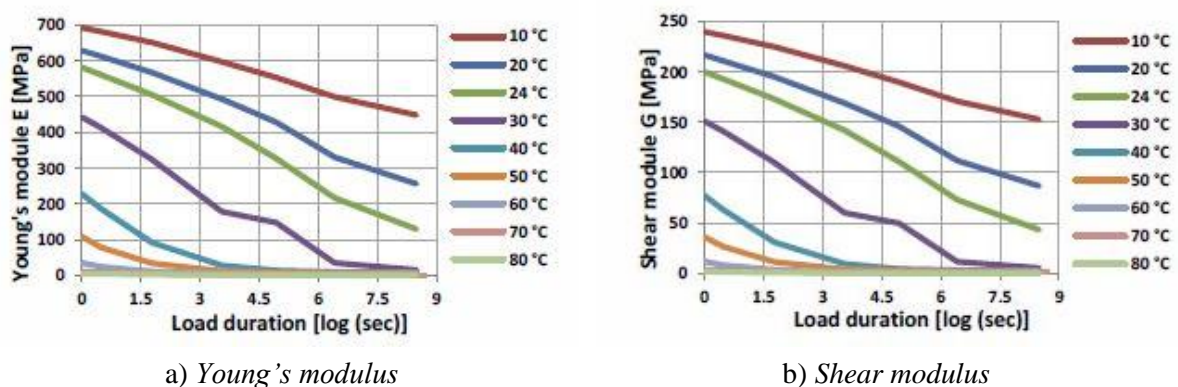
Figure 3.4 – Degradation of the SG properties with the increase of temperature and load-duration, (Stelzer, 2010).

The mechanical behavior of polymers is extremely dependent on external factors such as temperature, time, loading rate, UV- radiation, and environmental parameters like humidity or oxygen (among others) (Figure 3.4).

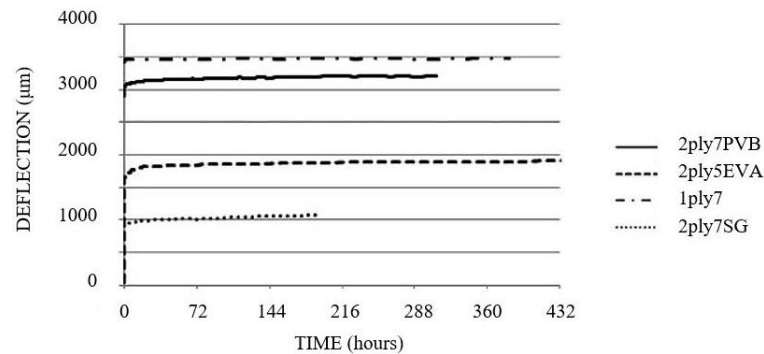
Figure 3.6 - Results of the 4PB tests, (adapted from Bati, *et al.*, 2010).

The measured deflections are presented in Figure 3.6 and confirm the strong influence that the viscosity of the adhesive layers has on the mechanical response of composite beams. The results showed that each of the analyzed polymers affected the mechanical response of the beams in a different manner and that their performance degraded at different rates, as consequence of their time-dependent behavior. The evolution of the deflections in all the tested samples is almost linearly dependent on time. It is also noted that the SG-laminates displayed stronger bonds and favorable long-term behavior, by presenting considerably smaller deflections.

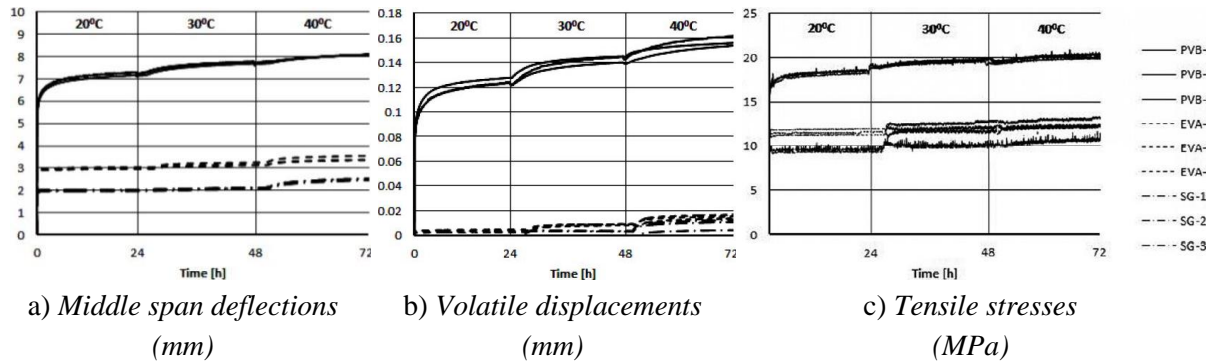
Figure 3.7 - Experimental results of four-points bending tests at +20°C, +30°C and +40°C, (adapted from Serafinavicius, *et al.*, 2013).

While EVA and SG laminates displayed similar results, PVB laminates presented the worst behavior, which is particularly visible in the results presented in Figure 3.7. The obtained results demonstrated that, under long-term loading, that the SG-laminates had the best performance, displaying considerably smaller values of the measured parameters, even at the highest considered temperature. When comparing the results of PVB and SG laminates it is important to refer that the percentage of differences between the recorded deflections, volatile displacement and tensile stresses are of 71%, 99% and 46%, respectively.

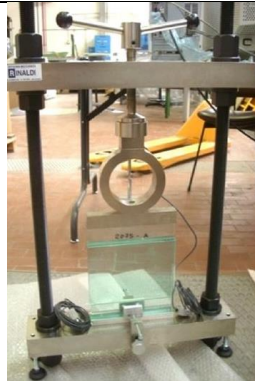
Evaluated Parameters: Temperature (T); Relative Humidity (H); Load Duration (L); Unload Time (U).	
	Tested Situations: a) T: 50°C, H: 70%, L: 13 days, U: 0 days; d) T: 20°C, H: 90%, L: 40 days, U: 26 days; b) T: 30°C, H: 70%, L: 30 days, U: 7 days; e) T: -5°C, H: 50%, L: 23 days, U: 0 days; c) T: 20°C, H: 50%, L: 37 days, U: 32 days; f) T: -20°C, H: 50%, L: 6 days, U: 0 days;

Figure 3.8 – Load and displacement as a function of time, (adapted from Biolzi, et al., 2014).

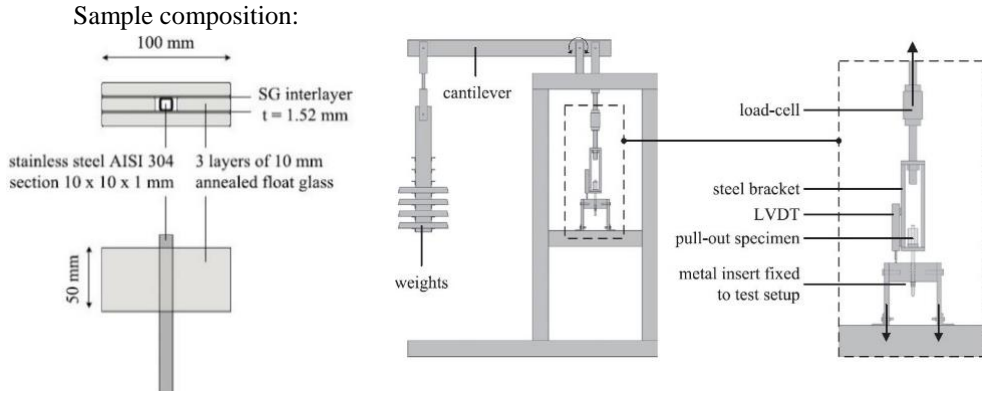
<p>The diagram shows the sample composition and the test setup. The sample consists of a stainless steel AISI 304 section (10 x 10 x 1 mm) embedded in three layers of 10 mm annealed float glass, with an SG interlayer (t = 1.52 mm) between the glass layers. The total width is 100 mm and the height is 50 mm. The test setup includes a cantilever beam with weights, a load-cell, a steel bracket, an LVDT, and a metal insert fixed to the test setup.</p> <p>Evaluated Parameters: Temperature (-20°C, 23°C, 60°C and 80°C); Thermal Cycling; Humidity Exposure; Load-duration.</p>

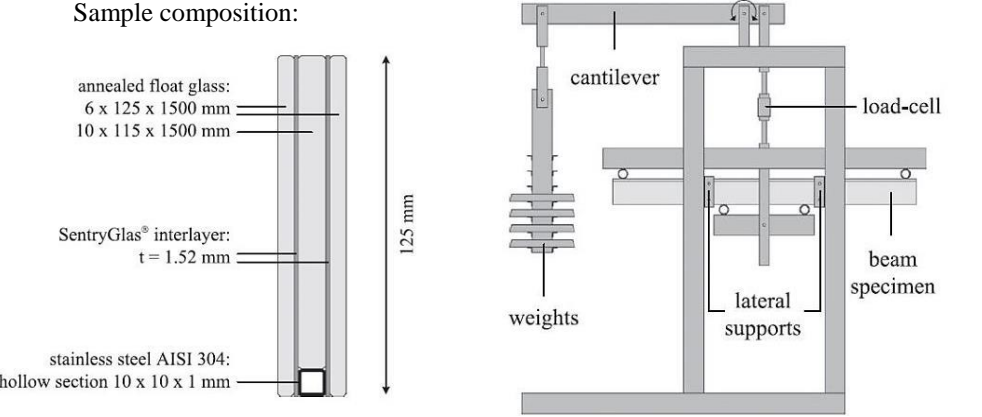
<p>The diagram shows the sample composition and the test setup. The sample consists of two layers of annealed float glass (6 x 125 x 1500 mm and 10 x 115 x 1500 mm) with a SentryGlas® interlayer (t = 1.52 mm) between them, and a stainless steel AISI 304 hollow section (10 x 10 x 1 mm) embedded in the bottom layer. The total height is 125 mm. The test setup includes a cantilever beam with weights, a load-cell, lateral supports, and a beam specimen.</p> <p>Evaluated Parameters: Load-duration, Temperature (-20°C, 23°C and 60°C); Thermal Cycling; Humidity Exposure.</p>

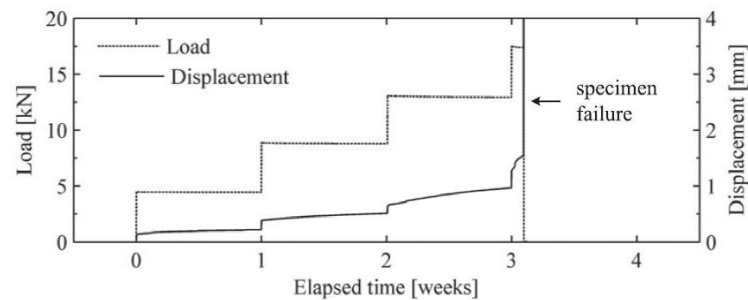
Figure 3.9 – Long-term pull-out tests - loads and displacements, (Louter, et al, 2011).

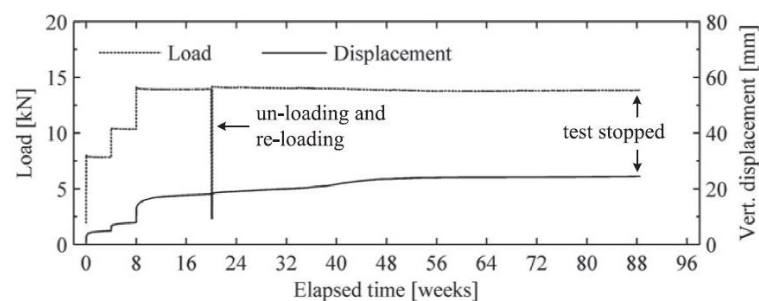
Figure 3.10 – Long-term bending tests - loads and vert. displacements, (Louter, et al, 2011).

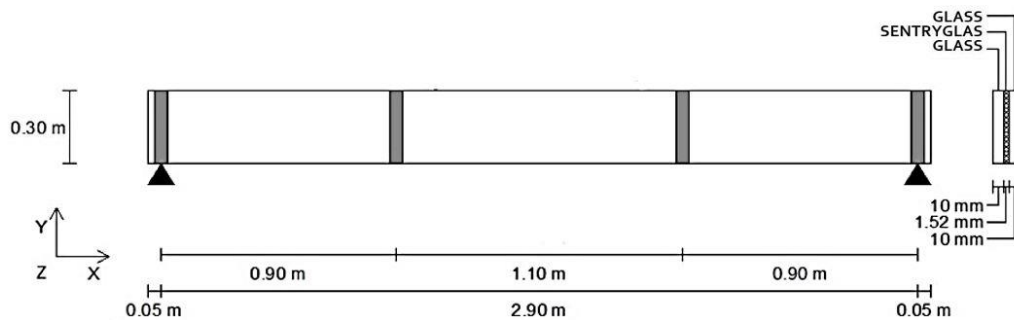
Figure 4.1 – Experimental layout and model geometry.

The experimental investigation consisted on the development of 4-point bending tests (Figure 1.2), including both intact and cracked models. The applied load-term actions included the self-weight of the beams and environmental temperature. The impact of these actions in the strains and vertical displacements of the tested models were analyzed during approximately 13 months.

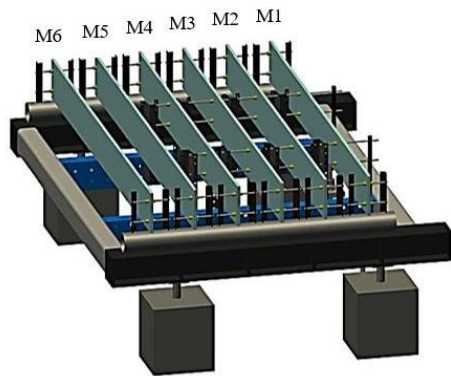
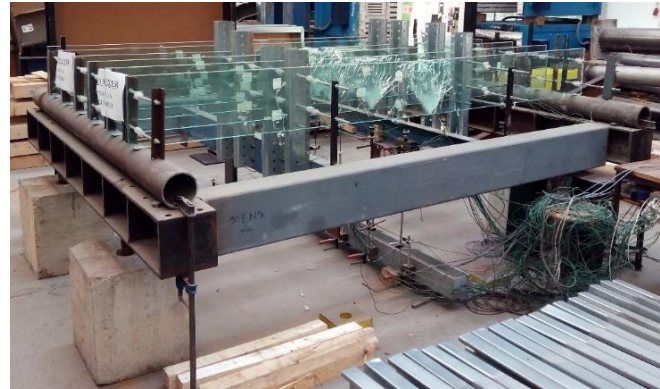
a) Model identification

b) Layout's perspective

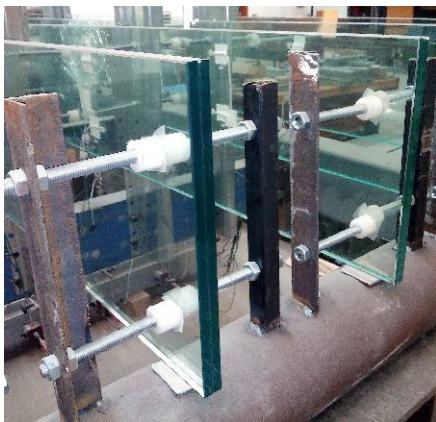
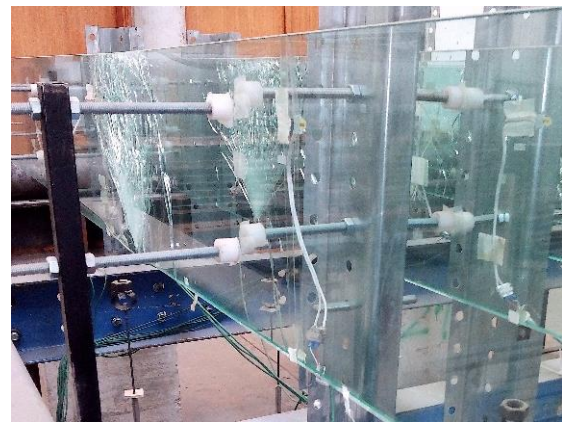
a) Simple vertical support and lateral support

b) Lateral support

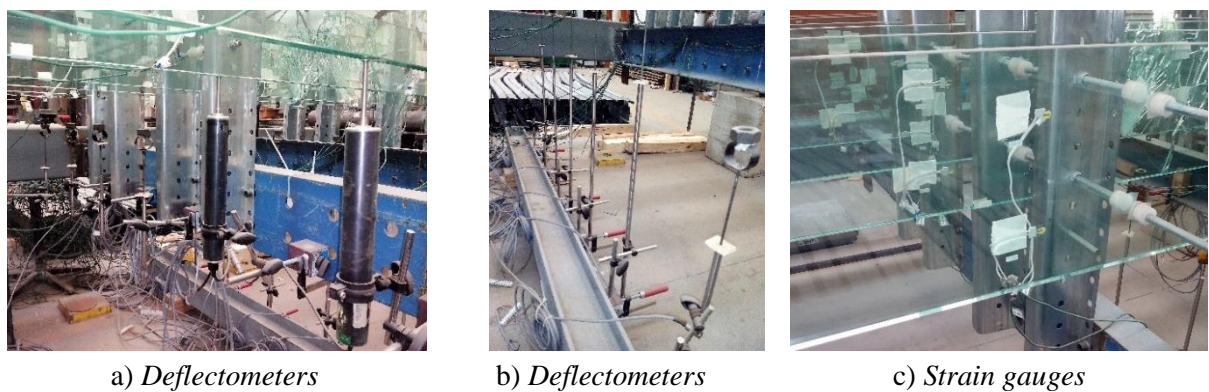
Figure 4.4 – Instrumentation.

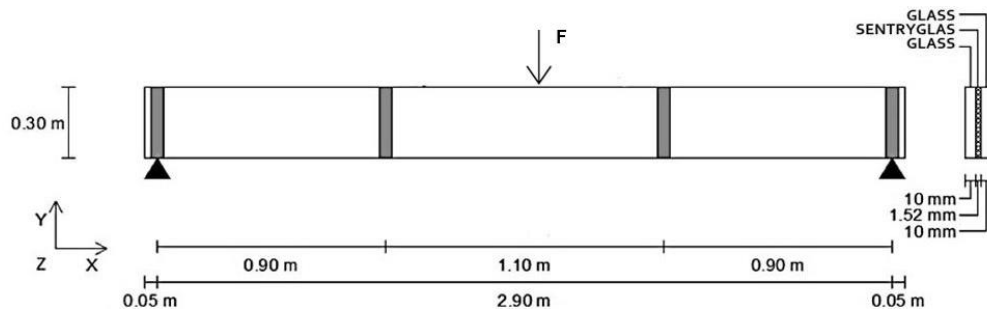
Figure 4.6 – Loading scheme.

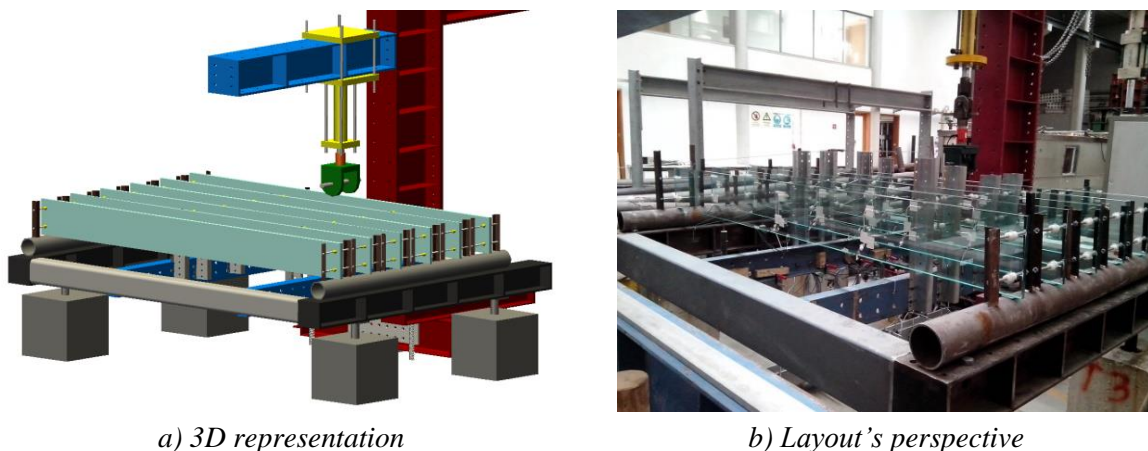
a) 3D representation

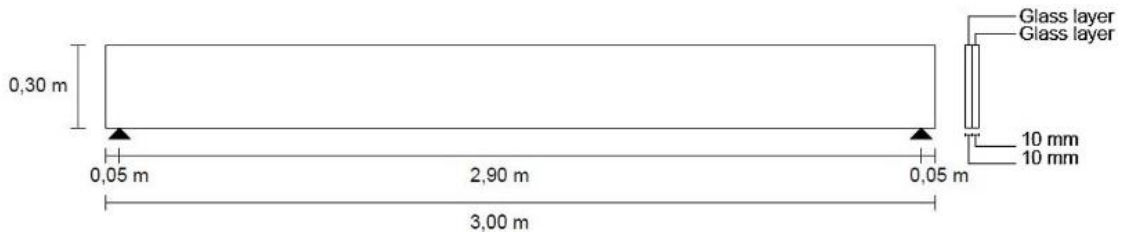
Figure 4.8 – Adopted model geometry for the determination of the theoretical strains.

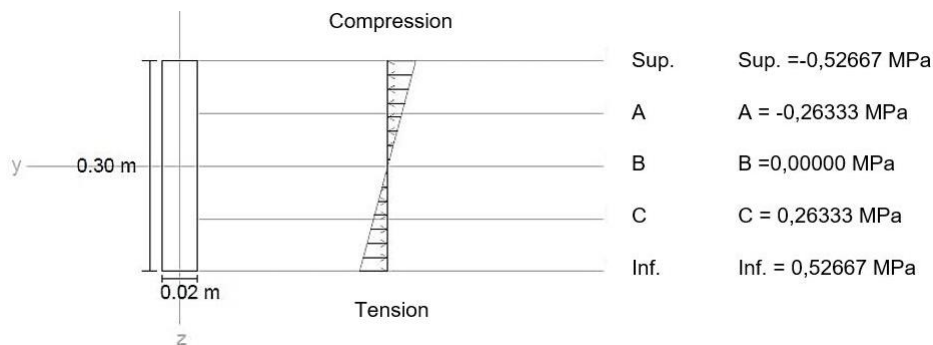
Figure 4.12 – Diagram of the stresses for the bending moment at midspan.

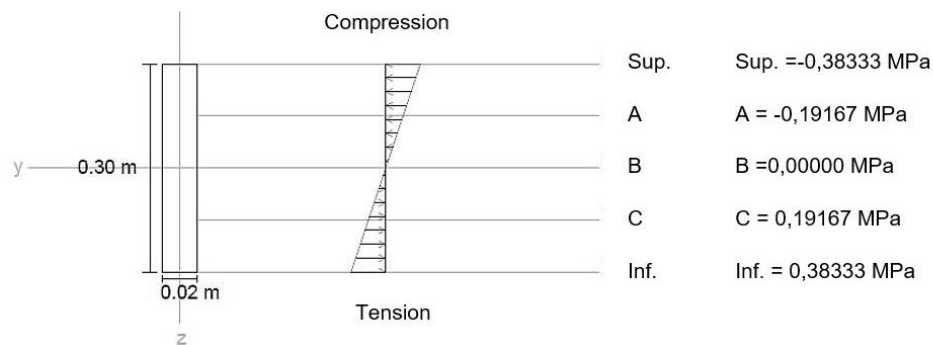
Figure 4.13 - Diagram of the stresses for the bending moment at $\frac{1}{4}$ of the span of the beams.

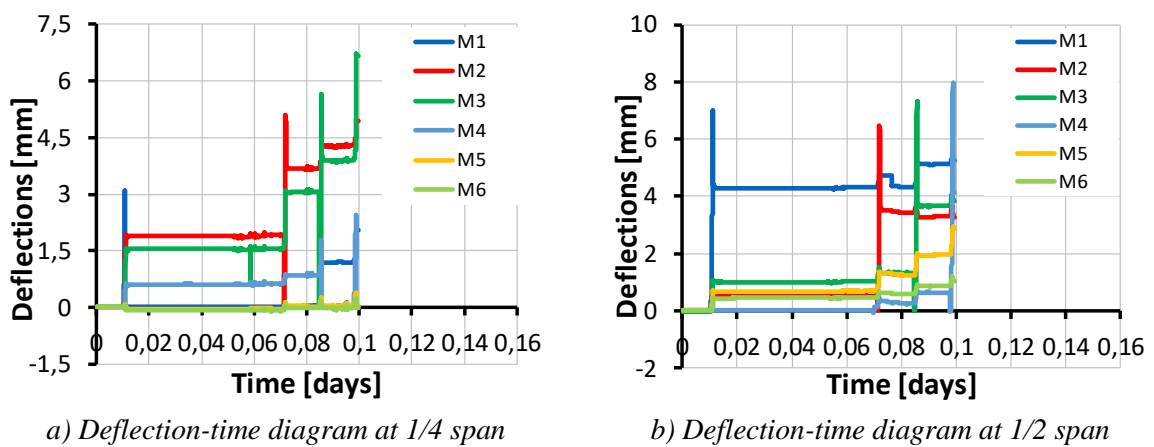
Figure 4.14 - Loading-phase results – Deflection-time diagrams.

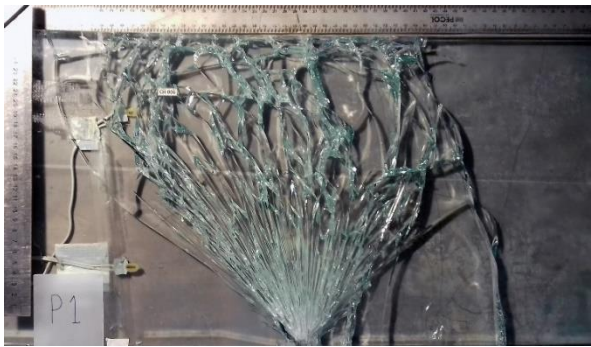
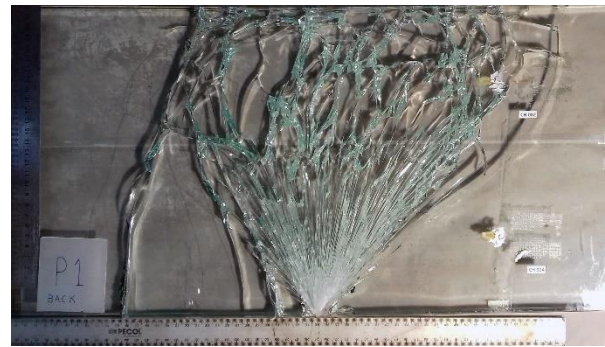
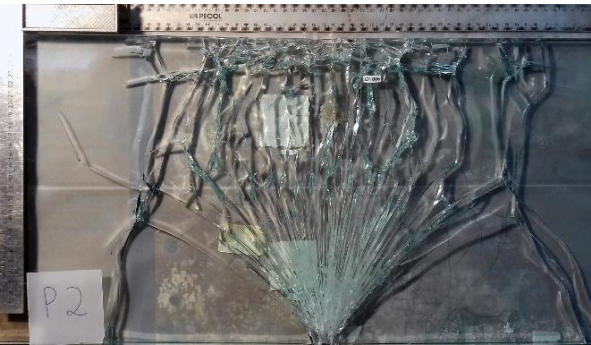
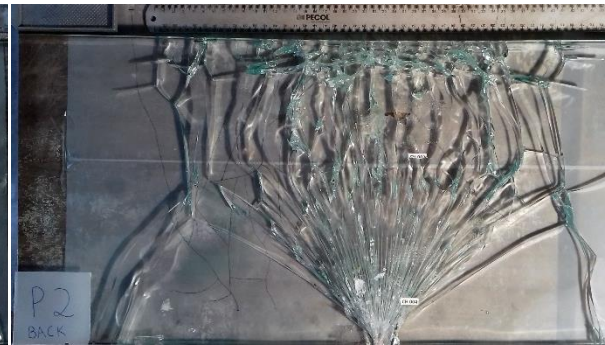
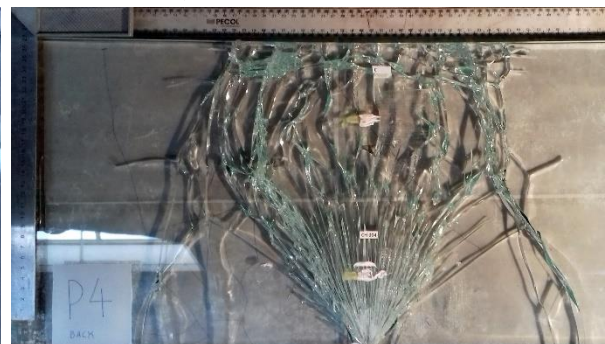
a) Model 1 – Front view

b) Model 1 – Back view

c) Model 2 – Front view

d) Model 2 – Back view

g) Model 4 – Front view

h) Model 4 – Back view

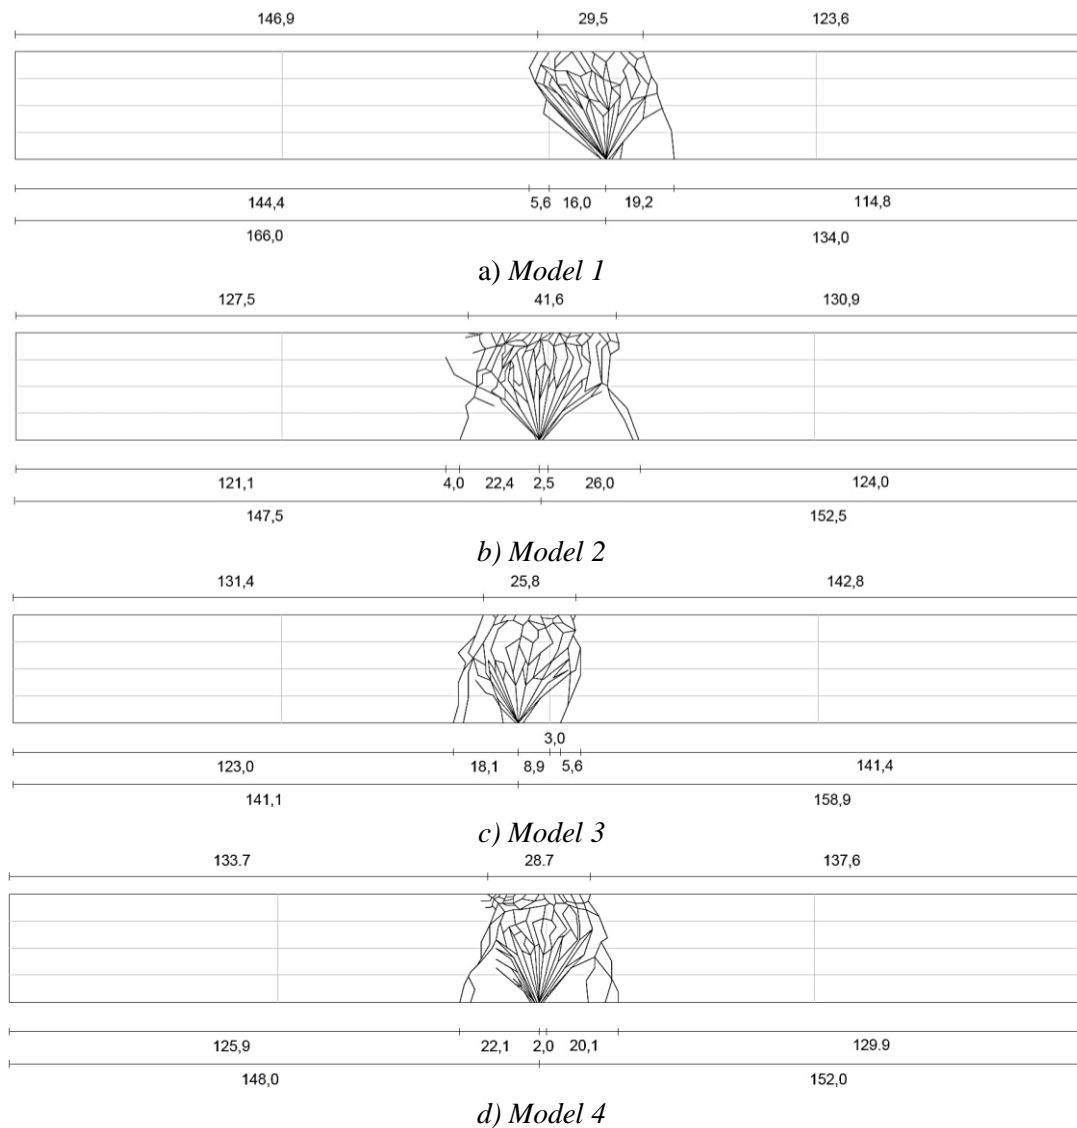
Figure 4.17 - Schematic representation of the final fractures (dimensions in millimeters).

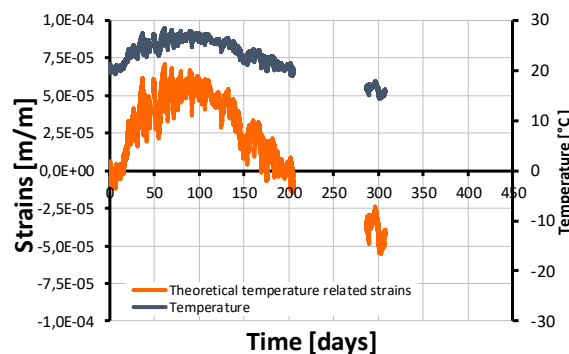
Figure 5.10 – Theoretical temperature related strains.

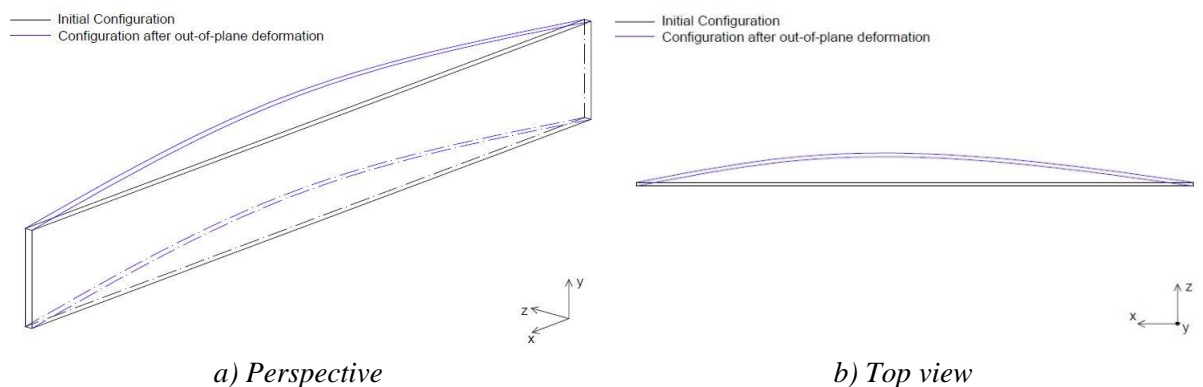
Figure 5.11 – Out-of-plane deformation in the experimental models.
