BUCKLING OF STEEL AND COMPOSITE STEEL AND CONCRETE COLUMNS IN CASE OF FIRE

Antonio M. Correia* and João Paulo C. Rodrigues **

Abstract. *Bare steel columns are known to have a very low fire resistance. The high thermal conductivity and the sudden decrease of the steel yield stress and Young Modulus in function of the temperature are responsible for this behaviour. The purpose of this study is to compare different modes of failure of building steel columns. The buckling of the columns is strongly influenced by the contact with other elements such as brick walls. Three types of situations were compared: steel columns embedded on brick walls, bare steel columns and composite columns made of partially encased steel sections. The deformed shapes of the columns are analyzed in this work.*

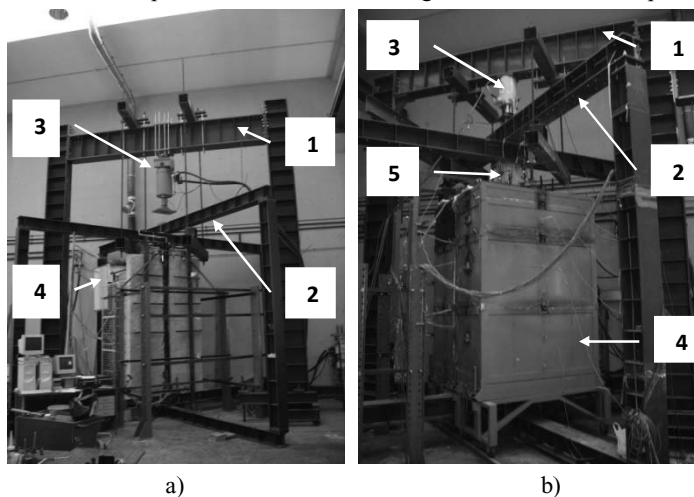
Figure 1 presents the test set-up, which were especially constructed in the Laboratory of Testing Materials and Structures of the University of Coimbra, for fire resistance tests on building columns embedded on brick walls (a) and isolated (b), both with restrained thermal elongation.

Figure 1: Experimental set-up a) columns embedded on walls b) isolated columns

This system comprised a 3D restraining steel frame of variable stiffness (2) with the function of simulating the stiffness of the surrounding structure to the column subjected to fire. The use of a three-

This load was applied by a hydraulic jack of 3MN and was controlled by a load cell of 1MN placed between the upper beam of the 3D restraining frame and the hydraulic jack. The hydraulic jack was placed in a 2D restraining frame (1), in which was also placed a safety structure to prevent sudden collapse of the specimen.

In the test set-up for testing bare columns (fig. 1b), the thermal action was applied by a modular electric furnace (4). This furnace is composed by two modules of 1m and one module of 0.5m height, placed on top of each others, forming a chamber around the column of about 1.5m x 1.5m x 2.5m. In the testing set-up for columns embedded on walls, the thermal action was applied by a gas fired furnace, 2 meters height and 1 meter wide (4) (fig. 1a). Both furnaces followed approximately the standard ISO 834 fire curve.

A special device was built to measure the restraining forces generated in the testing column during the fire resistance test (5). It consists of a hollow and stiff steel cylinder, rigidly connected to an upper beam above the specimen. On top of the specimen was rigidly connected a massive steel cylinder that entered into the hollow cylinder. The massive cylinder was Teflon lined in order to prevent friction with the hollow cylinder. Inside the hollow cylinder there was a compression load cell of 3 MN to measure the restraining forces.

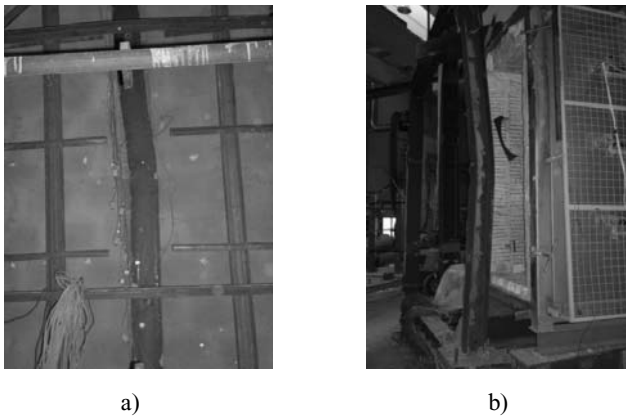
The thermal bowing is a phenomenon in which the differential thermal action leads to an inversion of the deflection if the structural element, from one to the other side. This was observed in test E02, as showed in figures 2a) and 2b). This column has suffered at first, a deflection towards the side of the fire, and afterwards a deflection towards the opposite side, outside of the fire.

Figure 2: Column E02 after test - web perpendicular to wall – wall thickness 140mm - HEA 160

This is most likely to happen in steel columns with the web perpendicular to the wall surface, but it can also occur in case of the steel profile placed with the web parallel to the wall surface, as long as the upper beams are strong enough to withstand the applied load.

The differential heating provoked a redistribution of bending moments, moving from one to the other side, following the lateral displacements of the column.

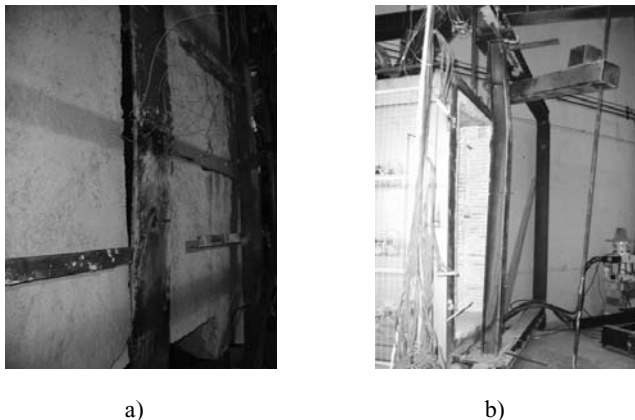
Figure 3: Column E13 after test - web perpendicular to wall – wall thickness 100mm - HEA 160

In figures 3a) and 3b), is observed column E13 after test. A HEA160, with the web perpendicular to the wall surface, is tested. The wall is 100mm thick, about 65% the column width. In this case, the

thermal gradient through the columns cross-section was not as strong as in test E02, leading to buckling in the plane of the wall. The wall plays an important role in preventing the sudden failure of the column.

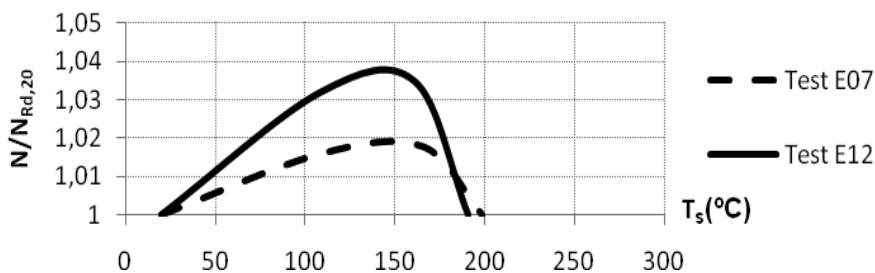
Figure 4 presents the evolution of restraining forces versus mean temperature of the steel columns, for tests E07 and test E12. It is observed that the decreasing of restraining forces after the maximum is quite gentle meaning with this failure by bending. Also, it was concluded that the thicker walls provide a greater insulation to the steel profile, giving as result a lower increase of the restraining forces and higher fire resistance.

Figure 4: Restraining forces on columns embedded on walls in function columns mean steel temperature

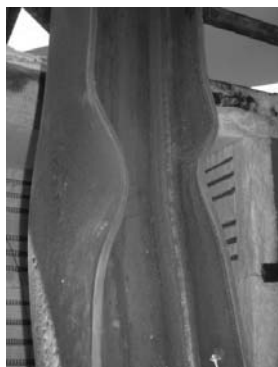
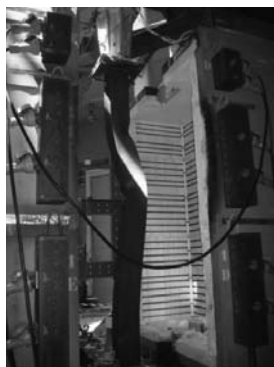
Figure 5: Column E15 after test

a) local buckling

b) global buckling

The buckling modes observed in the steel bare columns were global and local buckling for columns HEA200 (fig. 5a) and 5b)) and only global buckling for columns HEA160 (fig. 6). The columns presented in figures 5 and 6 were tested with the load level of 70% and stiffness of the surrounding structure of 13 kN/mm.

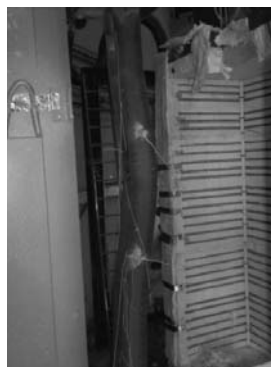
Figure 6: Column E18 after test

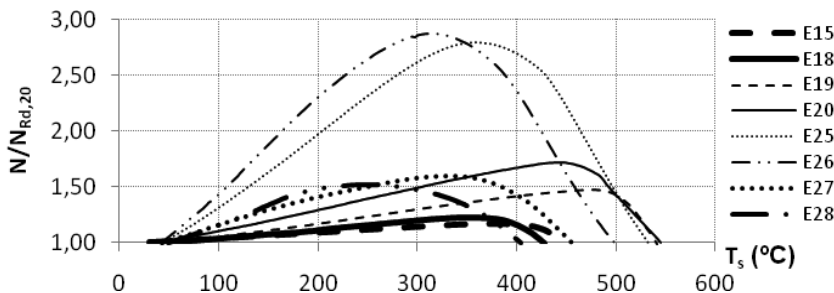
Figure 7: Restraining forces in bare steel columns in function of columns mean steel temperature

Figure 7 presents the evolution of restraining forces in bare steel columns in function of columns mean steel temperature. It can be observed that the lower load levels and higher the stiffness of surrounding structure, the higher the restraining forces. The restraining forces decrease in the major part of the cases not so sudden meaning global buckling of the columns.

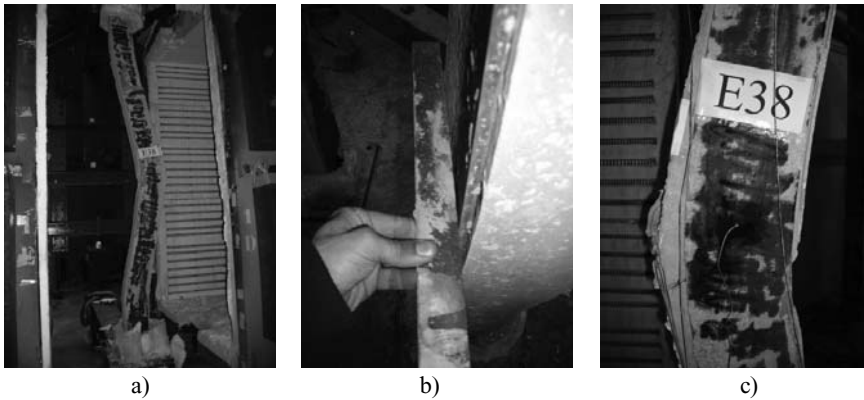
In composite steel and concrete columns regardless the load level, type of cross section, and stiffness of surrounding structure, was only observed global buckling however with detachment of the concrete between flanges (fig. 8a)).

Figure 8: Column of test E38 after test

As it can be seen in figure 8b), the concrete between flanges prevented the buckling of these. The failure of some composite columns was observed with the detachment of the stirrups from the web allowing the concrete to move away as a block (fig. 8c)).

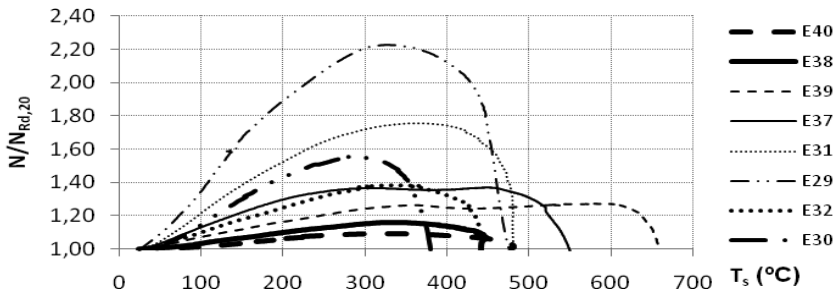
Figure 9: Restraining forces on composite columns in function of columns mean steel temperature

Figure 9 presents the evolution of restraining forces in the composite steel concrete columns in function of mean steel temperature. The conclusions are the same as for the steel columns. The lower the load level and the higher the stiffness of the surrounding structure the higher the restraining forces. A more pronounced descending of the restraining forces is observed in this case that could be associated to the detachment of the concrete between flanges.
